# SERVICE BULLETIN

M-979

MAY 23, 1989

## SEALING DIN CONNECTOR ON FLTC AND FLHTC ULTRA MODELS

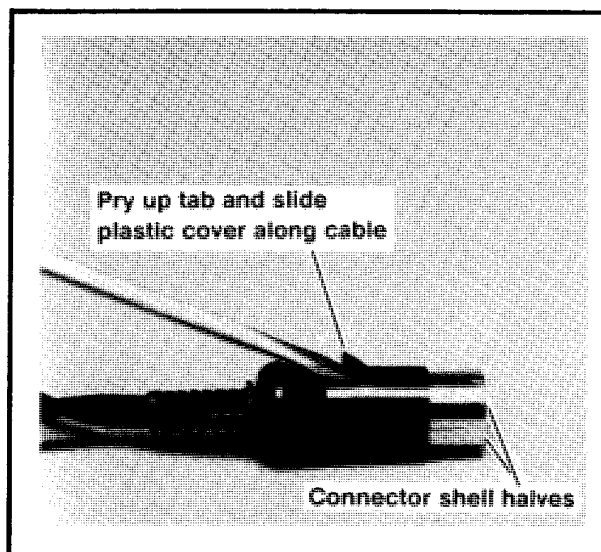
Figure 1. Disassembling DIN Pin Connector

The purpose of this Bulletin is to inform you of a possible problem you may encounter on Ultra Models. The problem is caused by water entering the 3-pin DIN connector that is connected directly to the console pod. This water shorts pin 2 to ground and causes continuous muting of the radio.

6. Note the position of the metal connector shell halves and remove one of the shell halves.
7. Check for water. If water is present, dry connector with compressed air or a heat gun.

5. See Figure 1. With screwdriver, pry up lock tab on plastic cover and slide cover off the connector and onto the cable.
