# SERVICE BULLETIN

M-981

JUNE 2, 1989

## COIL WIRE TERMINAL REPLACEMENT

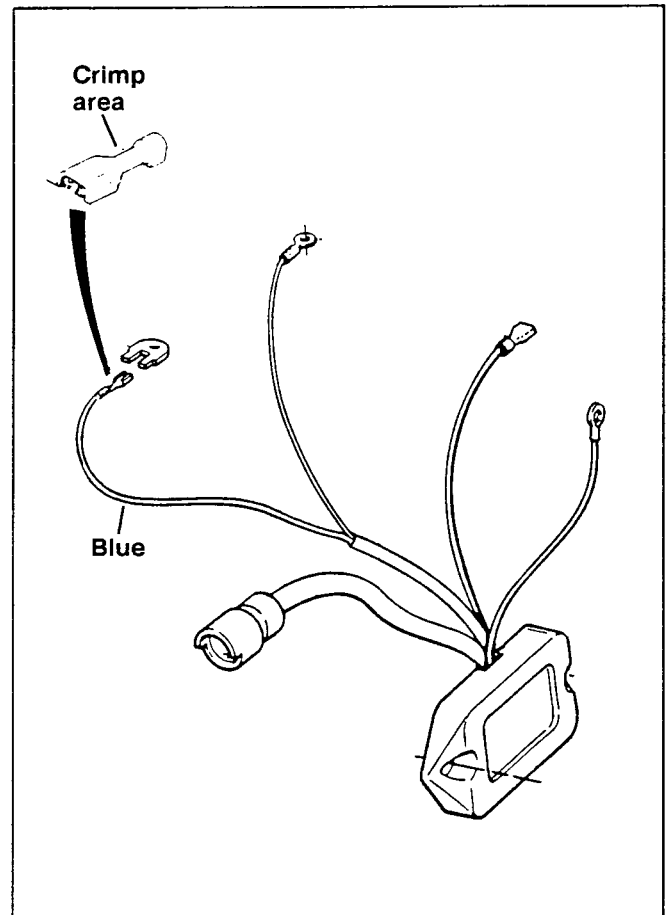
Figure 1. Ignition Module

As advised in our mailgram of May 11, 1989 all model vehicles built between April 20, 1989 and May 5, 1989 may have an improperly crimped ignition module wire terminal. Vehicles that have this condition could develop erratic engine operation, misfiring or loss of ignition spark. The suspect modules are identified with a date code of 1689, 1789 or 1889. If you have sold any vehicle from this build period, please contact the owner and arrange to replace the coil terminal as soon as possible. Parts order modules with these date codes must be repaired also. It is also possible that some improper crimping could have occurred prior to April 20. For this reason we suggest that if any late 1989 vehicles, built prior to May 5, exhibit ignition related problems the first step in your correction process should be the replacement of the blue coil wire terminal.

See Figure 1. The problem is confined to the terminal on the blue coil wire covered by a hard plastic insulator. The insulator makes visual inspection and pull testing impossible. As a result, the terminal should be cut from the wire and a new terminal, Part Number 9900, installed. Ignition modules on vehicles in York inventory, at the time the problem was discovered, were repaired and are identified with a white or yellow stick-on dot. The blue wire terminal on modules marked with a yellow or white dot do not require replacement.

On most of the vehicles the coil is readily accessible after removing the coil cover. FLT models, however, will require removing the fuel tank front mounting bolt and loosening the rear two screws attaching the fuel tank bracket to the frame. The front of the fuel tank can then be lifted for better access to the coil. Upon completion of the repair submit a properly completed warranty claim using labor
