SERVICE BULLETIN

M-982

JULY 7, 1989

883cc SPORTSTER PISTONS

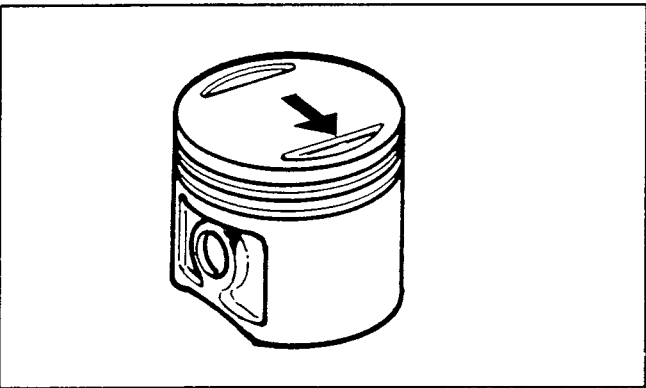
Figure 1. Late 1989 883cc Piston

As a running change in late 1989, 883cc pistons have offset piston pins. These pistons were implemented in production starting with crankcase number 1789156001. Offset pins are meant to reduce piston noise. The new 883cc pistons will have an arrow stamped into the top of the piston. see Figure 1. This arrow must point towards the front of the engine when the pistons are installed.

Installing the piston, backwards, will increase piston noise.

Except for observing piston direction during replacement and installation, all other piston service procedures remain unchanged. Service procedures relating to the piston are found in the 1986-89 XLH Service Manual Part no. 99484-89.
