# SERVICE BULLETIN

M-986

September 15, 1989

## 1340cc CLUTCH PUSH ROD ADJUSTING STUD (ADJUSTER SCREW)

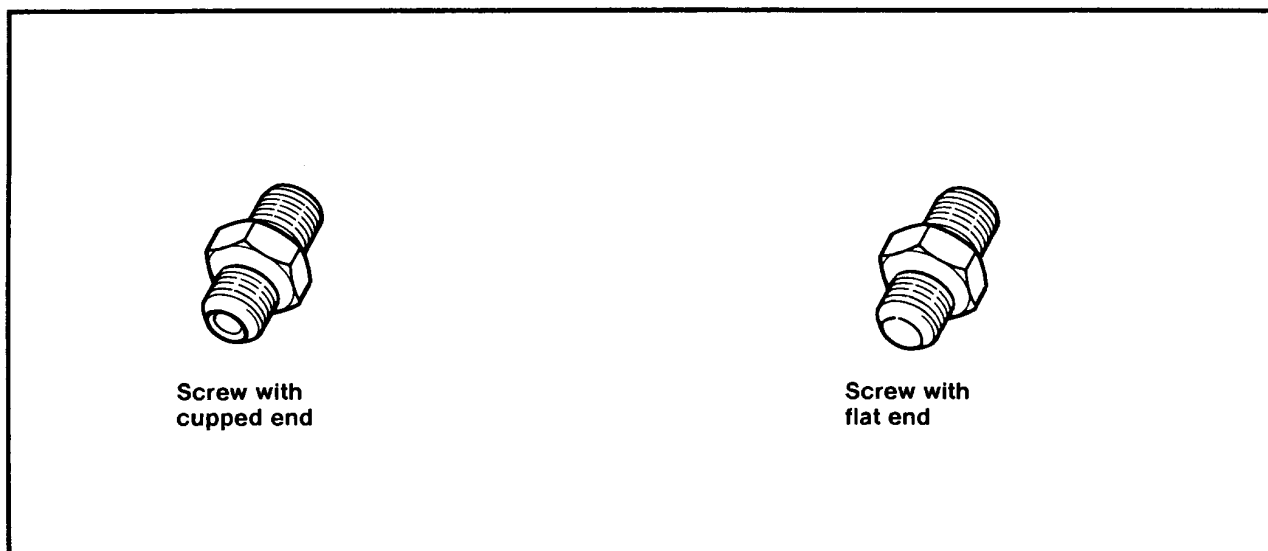
Figure 1. 1340cc Clutch Adjuster Screw End Comparison

See figure 1. From 7/10/89 to 7/29/89 an unknown quantity of 1989 and 1990 1340cc motorcycles were manufactured with a clutch push rod adjusting stud (adjuster screw) that was "cupped" at the push rod end.

Friction forces resulting from the cupped end create the potential for push rod bearing failure.

The symptom for push rod bearing failure will be excessive freeplay at the clutch lever.

When your 1340cc motorcycle customer comes in for his 500 mile check-up, inspect the push rod adjusting stud and if it is cupped, replace the cupped stud with a flat ended stud, Part No. 37357-84.
