SERVICE BULLETIN

MARCH 30, 1990

1340 CLUTCH INFORMATION FOR 1990 MODELS

M-991

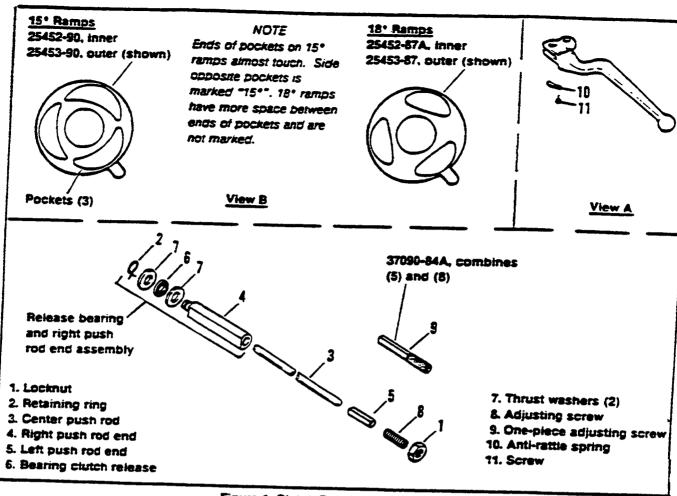
Figure 1. Clutch Release Components

See Figure 1. The left push rod end, Part No. 37090-84 and adjusting screw, Part No. 37357-84 have been replaced by a single item Part No. 37090-84A. This change reduces the possibility of clutch drag by decreasing any tendency for the clutch pressure plate to tip. This change was made to production vehicles in December, 1989.

See Figure 1, View B. Beginning March 28, 1990, transmission number 90087042, clutch release ramps, Part No. 25452-87A (inner) and 25453-87 (outer) will be used in production. These ramps will provide more movement (lift) to the push rod to further reduce the possibility of clutch drag. This change will stightly increase clutch lever effort.

See Figure 1, View A. During the installation of the one-piece adjusting screw and earlier release ramps, remove the anti-rattle spring (10) and its' retaining screw (11). The spring may affect free-play in the clutch lever and could cause the clutch throw-out bearing to be slightly loaded. That loading could cause premature tailure of the throw-out bearing.

If customers of early 1990 1340 cc models complain of difficulty finding neutral, verify proper clutch adjustment at the adjusting screw and correct Primary Chaincase Lubricant level (to outside diameter of diaphragm spring). If clutch adjustment and lubricant level are correct, install the one-piece adjusting screw, earlier release ramps and remove clutch lever anti-rattle spring and screw. Also, install the one-piece adjusting screw, earlier release ramps and remove clutch lever anti-rattle spring and

screw on all early 1990 1340 cc models that have a clutch release bearing/push rod failure.

- 3. See Figure 1. With a magnet, remove the left push rod end (1).
- Install new one-piece adjusting screw into release plate and install locknut (2) on adjusting screw. DO NOT ADJUST PUSH ROD NOW, adjust after release ramps have been installed.

- Refer to pages 7-30 and 7-31 in the 1985 TO 1990 FX/SOFTAIL MODELS Service Manual, Part No. 99482-90 for instruction on removing release ramps and installing the earlier ramps. See Figure 1, View B for identification of release ramps.
- 2. See Figure 1. After transmission side cover has been removed, remove the clutch release bearing and push rod assembly and center push rod (3). Install a new release bearing if excessive wear or overheating of bearing is evident. Also inspect the center push rod (3) for wear or damage, Install new push rod parts if required.
