SERVICE BULLETIN

HARLEY-DAVIDSON

M-993 MARCH 30, 1990

1990 SPORTSTER IGNITION WIRE REROUTING

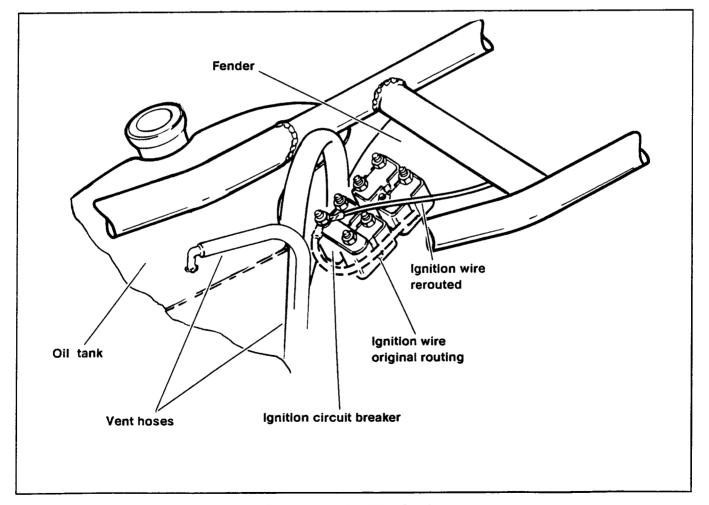
Figure 1. Ignition Wire Routing

Beginning with the 1990 XL model year production, variations in assembly could cause contact between the white ignition wire and the oil tank and/or transmission vent hoses

See Figure 1. The white ignition wire is connected to the copper stud at the ignition circuit breaker, located on the vehicle rear fender. The ignition wire as originally routed is shown in dotted lines. The wire in this location could in some cases contact the vent hoses. Vent hose movement with normal engine vibration could cause the wire to break. Vehicles that have this condition could develop

erratic engine operation, misfiring, or loss of ignition spark.

In February, 1990, a change was made in production to eliminate the potential ignition wire contact problem. This condition is easily corrected by loosening the nut on the stud and rotating the wire terminal upward, away from the hoses. The wire is then routed between the circuit breaker studs as shown in solid lines. Tighten the nut. When ever you are servicing a 1990 Sportster vehicle please examine the ignition wire to be sure it is not close to the vent hoses. If a vehicle is at all suspect, reroute the wire as shown in figure 1.
