SERVICE BULLETIN

M-1000

1991 XLH VOLTAGE REGULATOR WIRE REROUTING AND 1991 XLH/ FX SERVICE MANUAL CORRECTION

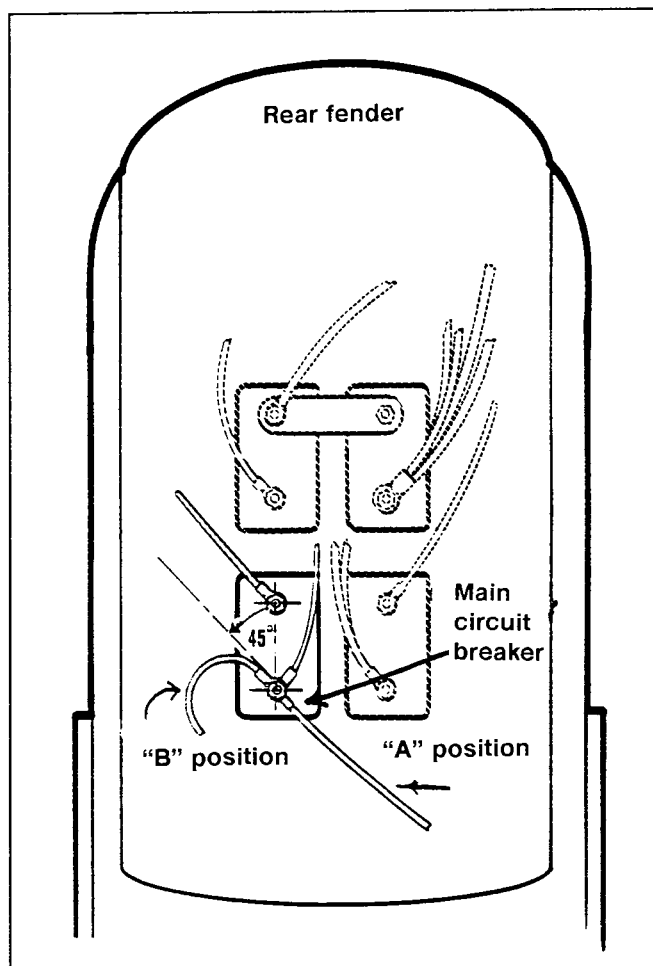
Figure 1. Voltage Regulator Wire Rerouting

1991 XL assembly variations could cause contact between the black voltage regulator wire and the oil tank or transmission vent hose. The voltage regulator wire is connected to the silver stud on the main circuit breaker. See Figure 1. To correct this condition, please rotate the regulator wire from "A" position to the "B" position. If this is not done the connector may fail leading to regulator damage and loss of battery power.

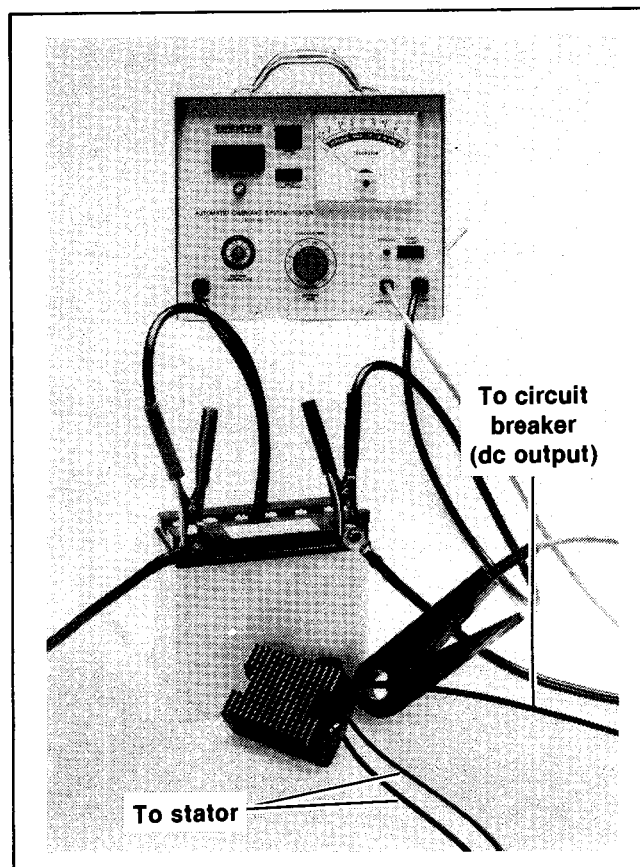
Figure 2. Charging System Output Test

The illustrations Figure 7-14 on page 7-18 in Section 7 of the 1991 XLH Service Manual and Figure 8-12 on page 8-16 in section 8 of the 1991 FX Service Manual are incorrect. The illustrations show the induction probe clamped around all three wires, within the conduit, connected to the voltage regulator. This is wrong. See Figure 2. The induction probe should instead be clamped around the output wire (d.c. current) to the main circuit breaker only. The two wires to the alternator stator (a.c. current) are not a part of this test. Please mark your XLH and FX Service Manuals accordingly.

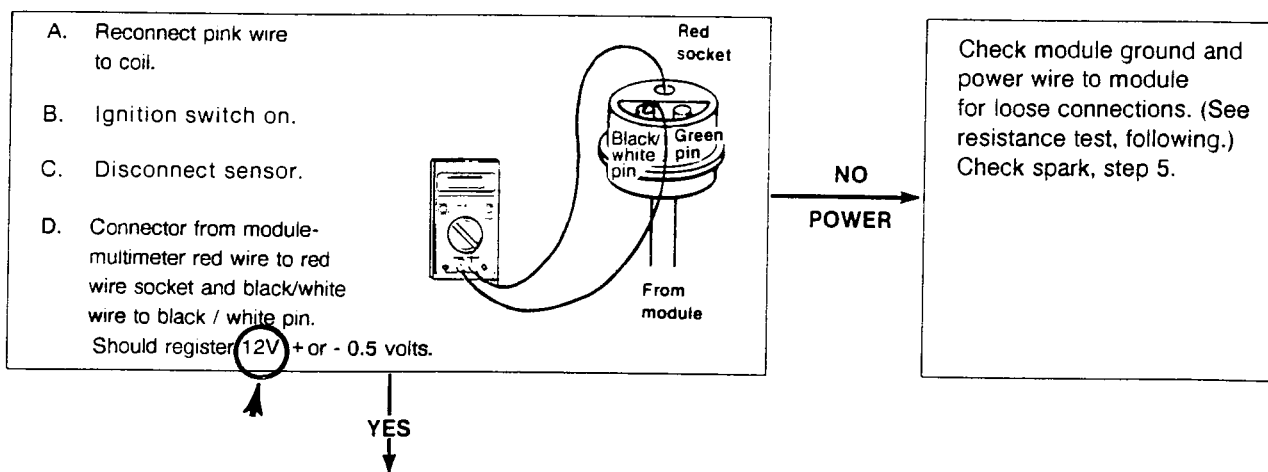
Figure 3. Trouble Shooting Ignition Module

Refer to the trouble shooting chart on page 8-4 in the 1991 FX Service Manual and page 7-4 in the 1991 XLH Service Manual. See Figure 3. Under "D" in step 4 the reading at the meter should register 12 volts and not 5 volts as indicated in the Service Manuals. Please mark your manuals accordingly.

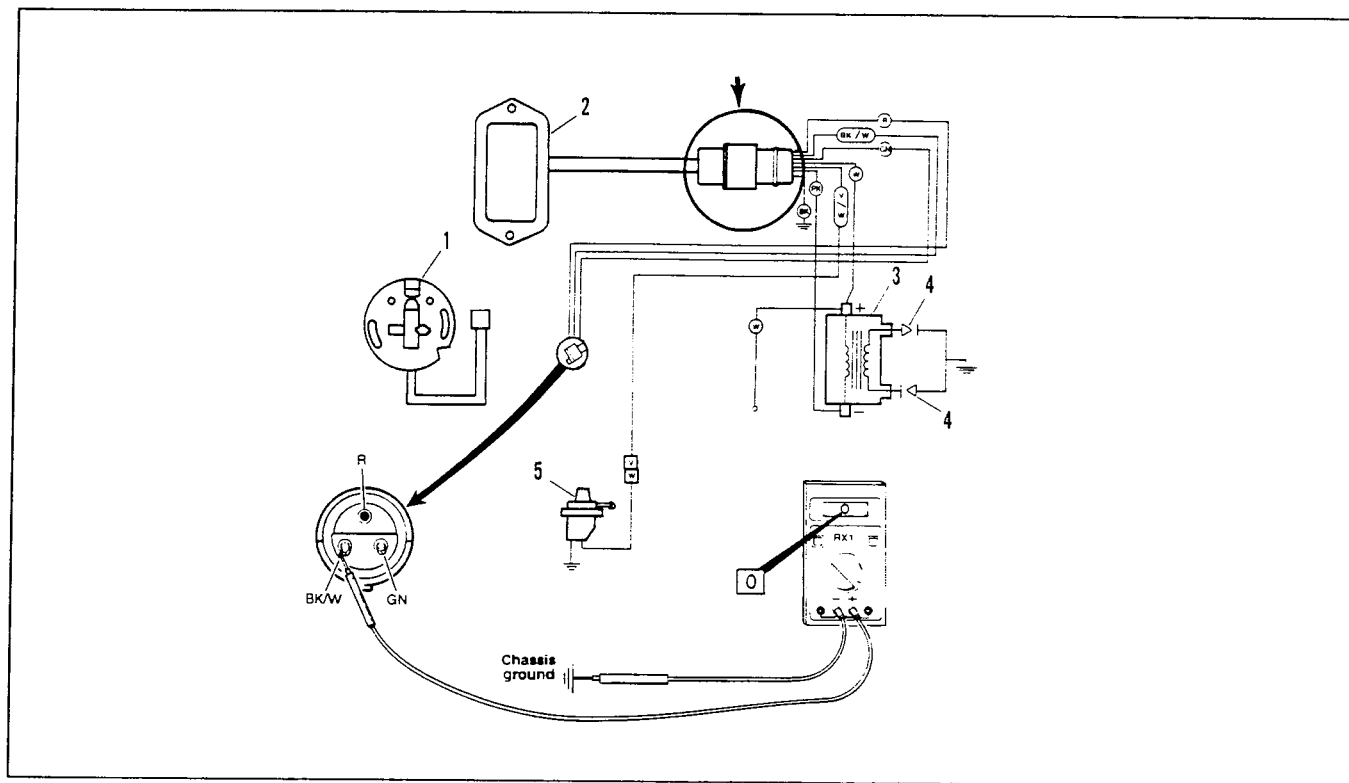
Figure 4. Resistance Test

Refer to the Resistance Test Chart on page 8-6 in the 1991 FX Service Manual and page 7-6 in the 1991 XLH

Service Manual. See Figure 4. The illustration, in the Service Manuals, does not show the new ignition module 7 pin connector. The ignition module on all 1991 models can be detached, electrically, by separating the 7-pin connector. Please mark your manuals accordingly.
