SERVICE BULLETIN

M-1006

December 12, 1990

1991 ALTERNATOR ROTOR AND COMPENSATING SPROCKET SPACING

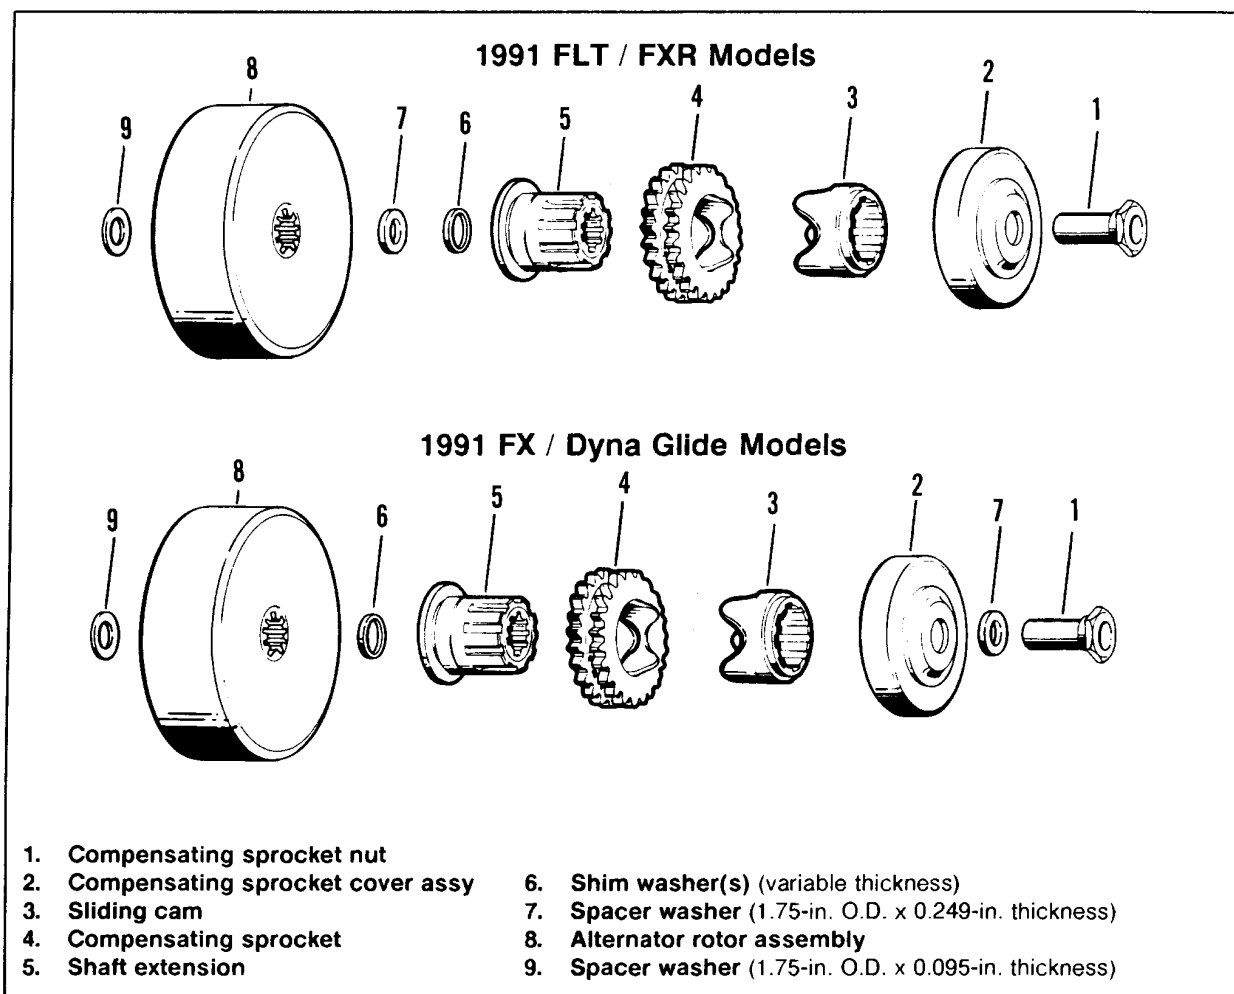
Alternator Rotor and Compensating Sprocket Assembly

This Service Bulletin is being issued to inform Dealers about alternator rotor and compensating sprocket spacing on 1991 model year motorcycles with 1340cc Big Twin engines. The positioning of the spacer/shim washers on 1991 Big Twins will vary, depending upon the particular motorcycle model involved. In addition, the spacer/shim washers used on 1991 Big Twins are different, in size and/or positioning, than those used on earlier models. See illustration below.

All Big Twin models have a 1.75-in. O.D. x 0.095-in. thick spacer washer (9) immediately inboard of the alternator rotor assembly (8) on the sprocket shaft.

On 1991 FLT / FXR models, a 1.75-in. O.D. x 0.249-in. thick spacer washer (7) is positioned immediately outboard of the rotor, followed by a variable thickness shim washer(s) (6), and then the shaft extension (5).

On 1991 FX / Dyna Glide models, the variable thickness shim washer(s) (6) is positioned between the rotor and the shaft extension (5); the 1.75-in. O.D. x 0.249-in. thick spacer washer (7) is positioned between the compensating sprocket cover assembly (2) and the compensating sprocket nut (1).
