SERVICE BULLETIN

M-1006

December 12, 1990

1991 ALTERNATOR ROTOR AND COMPENSATING SPROCKET SPACING

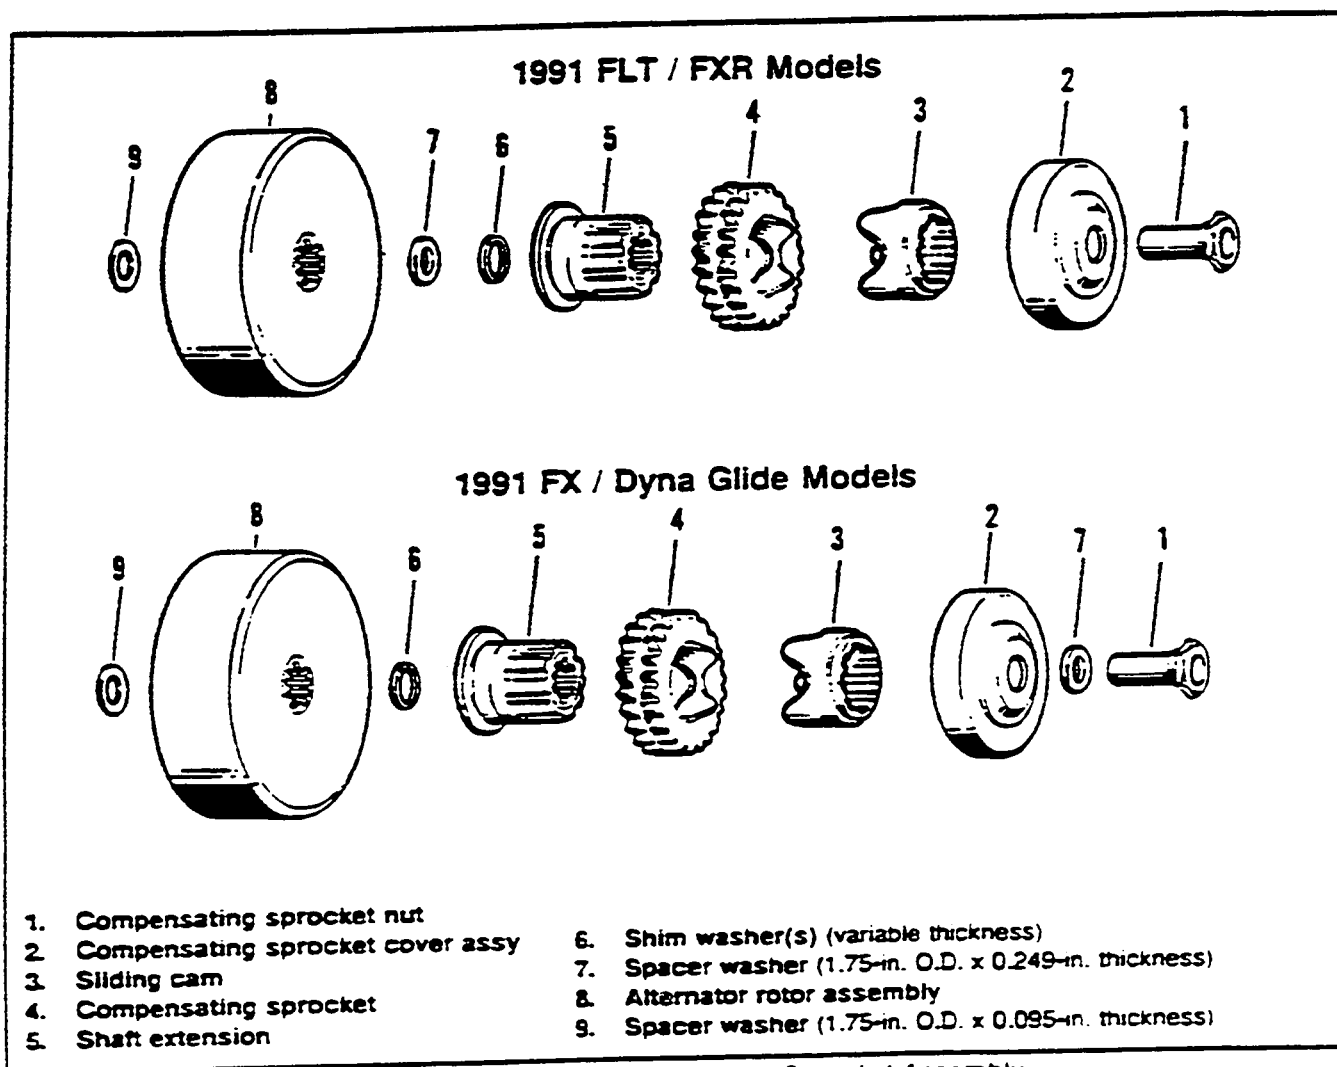
Alternator Rotor and Compensating Sprocket Assembly

All Big Twin models have a 1.75-in. O.D. x 0.095-in. thick spacer washer (9) immediately inboard of the alternator rotor assembly (8) on the sprocket shaft.

On 1991 FLT / FXR models, a 1.75-in. O.D. x 0.249-in. thick spacer washer (7) is positioned immediately outboard of the rotor, followed by a variable thickness shim washer(s) (6), and then the shaft extension (5).

On 1991 FX / Dyna Glide models, the variable thickness shim washer(s) (6) is positioned between the rotor and the shaft extension (5); the 1.75-in. O.D. x 0.249-in. thick spacer washer (7) is positioned between the compensating sprocket cover assembly (2) and the compensating sprocket nut (1).
