SERVICE BULLETIN

M-1018

October, 1990

NEUTRAL SWITCH – ALL MODELS

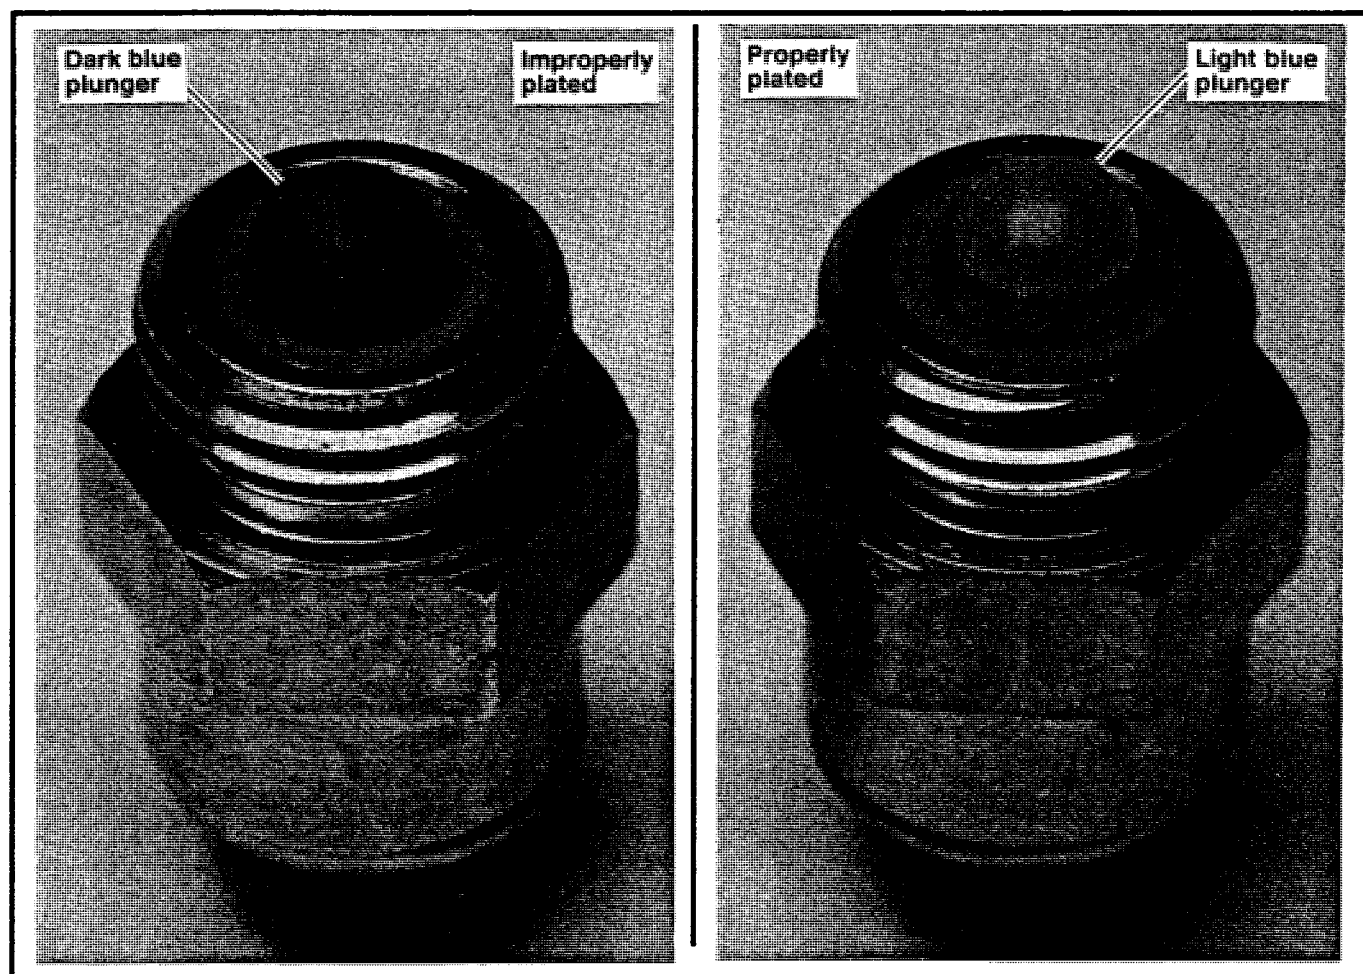
Neutral Switch Comparison

In 1992, as a product improvement, Harley-Davidson increased the hardness of the plunger in the neutral switch. On a certain number of switches, the plunger plating was done improperly.

Because of this condition, some of your customers may experience a flickering or no neutral indicator lamp when they shift their motorcycles into neutral.

See Illustration. The switches with improperly plated plungers can be identified by a very dark blue, almost black, plunger. Properly plated plungers have a light blue appearance.

Harley-Davidson will warranty replacement of the incorrectly plated switches. If your customer complains of a flickering or no neutral indicator lamp, the switch should

be replaced. If you have these switches in stock, replace them also. Follow normal warranty procedure.

The new switch, Part No. 33900-59A, can retrofit vehicles built before 10/1/91. The old switch, Part No. 33900-59, must not be used on vehicles built after 10/1/91. The purpose of using the light blue plunger is to easily identify the new switch.
