# SERVICE BULLETIN

M-1033

## SUPPLEMENTARY SERVICE BULLETIN FILE WITH SERVICE BULLETIN M-1032 (SAFETY RECALL CODE 082)

Supplementary Service Bulletin M-1033 contains additional information regarding Service Bulletin M-1032 (Safety Recall 082 - Starter Relay).

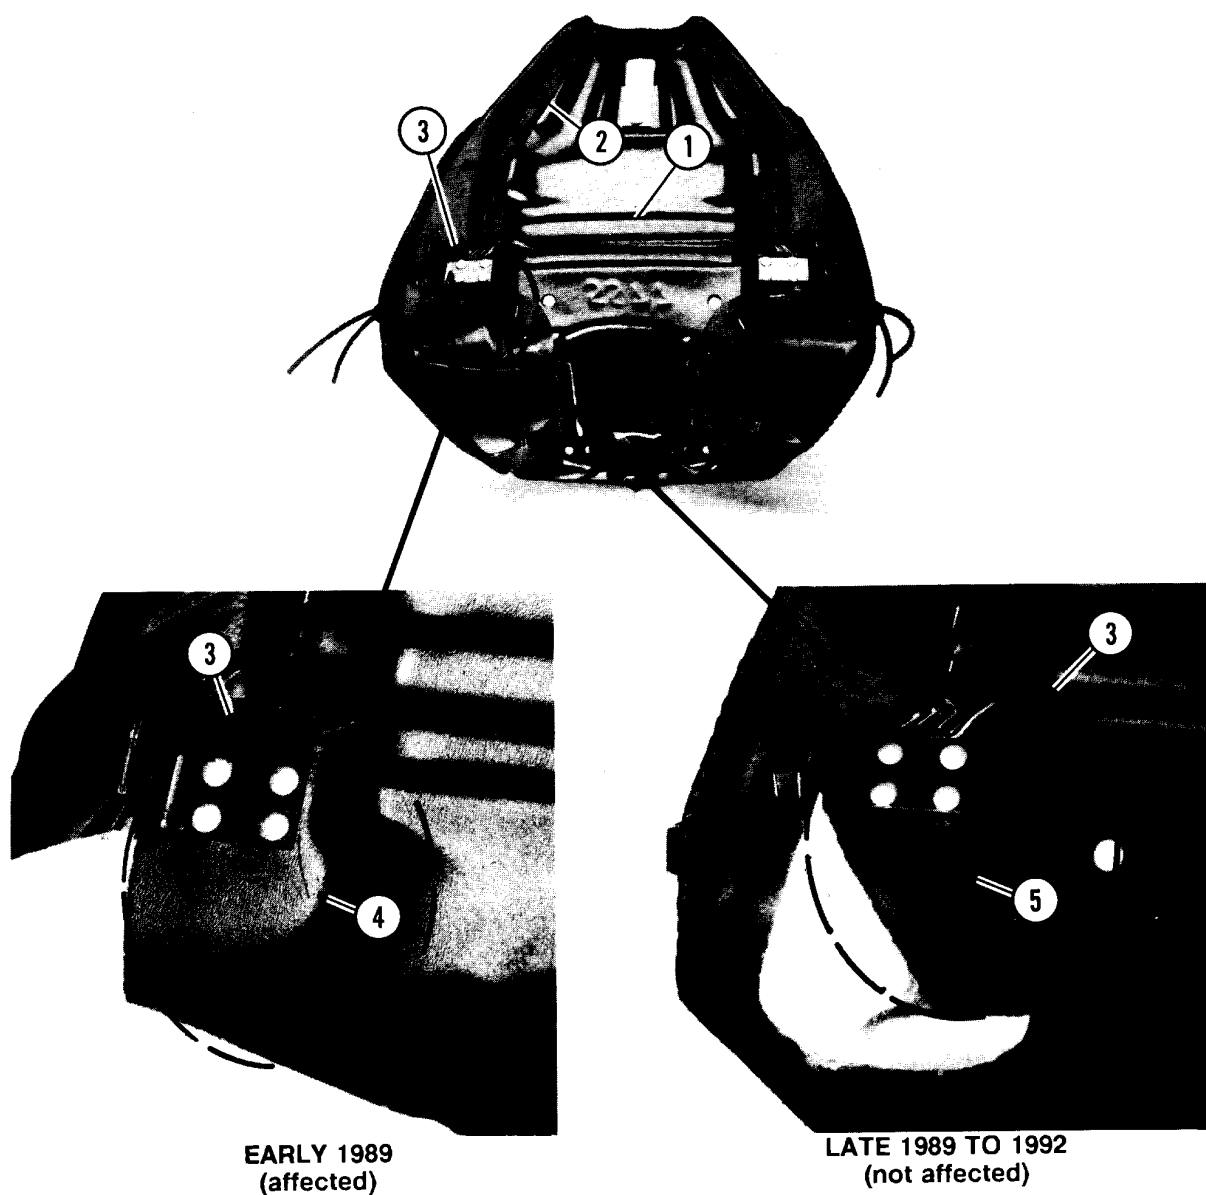
Figure 1. Typical Heritage-Style Softail Solo Seat

When performing the Service Bulletin M-1032 procedure on a Softail motorcycle, determine if your particular vehicle has an Early 1989 seat by comparing the seat pan with those shown in Figures 1 and 2. Early 1989 seats have a bulge (4) in the raised right rear corner (3) of the seat pan's (1) widest section; the bulge is positioned directly over the relocated starter relay with the seat installed. Late 1989 to 1992 seats have a smaller, flat surface (5) in the raised right rear corner (3) of the seat pan's (1) widest section.

1. Seat pan 2. Seat cover material 3. Raised right rear corner 4. Bulged surface 5. Flat surface

1. See Figures 1 and 2. With seat removed from motorcycle, use a small flat-tip screwdriver to remove staples securing seat cover material (2) to raised right rear corner (3) of seat pan's (1) widest section. You will need to remove a total of about 7 - 9 staples.
2. Lift loose seat cover material (2) away from raised right rear corner (3) of seat pan (1). Wrap aluminum foil over loose seat cover material to hold material away from affected area of seat pan; aluminum foil will also serve as a heat shield to protect seat cover material.

3. Use an electric forced-air heat gun to heat carefully the bulge (4) area of seat pan's (1) right rear corner (3). Hold heat gun approximately 1-1/2 to 2 in. (38 to 51 mm) away from surface of plastic. Continuously move heat gun over entire area to be reshaped, thereby heating plastic evenly. Continue to heat affected area until plastic can be deformed (using a small block of wood) without returning to its original shape; at this point, plastic is ready to be reshaped.

4. When plastic in affected area of seat pan is warm enough to reshape, use the end of a small block of wood to press plastic downward and outward until original bulge is reshaped into a flat surface (as shown in Figure 3) like that of Late 1989 to 1992 seat pans.
