# SERVICE BULLETIN

M-1036

Safety Recall Code 083

## KIT NO. 91080-93 SOCKET HEAD SCREWS

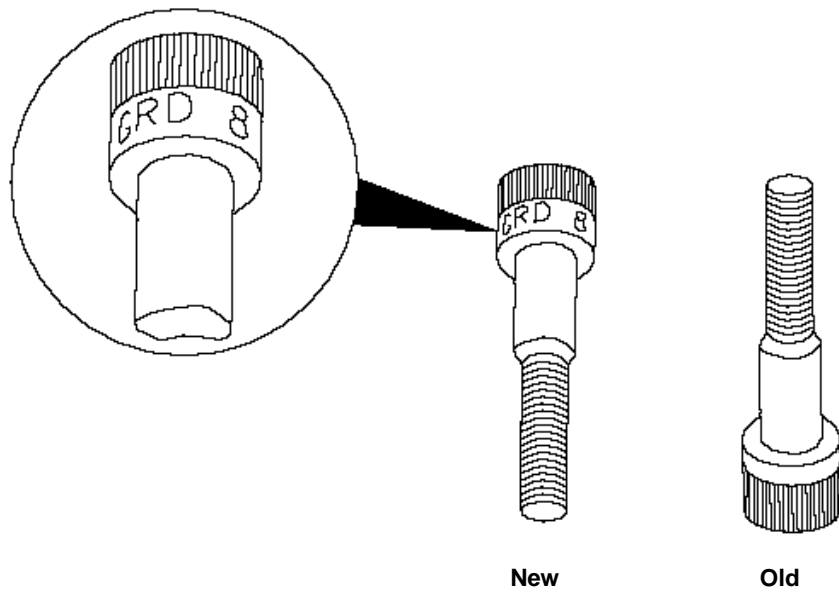
As stated in our August 12, 1993 Mailgram, ML-333, the Heritage chrome front fender rail kit, Part No. 91080-93 with a packaging date of 6/93, contains four (4) screws, Part No. 4326A, which could possibly break. If the screw(s) break, it could cause looseness of the fender and bumper. In some cases this may result in contact of these parts with the front tire.

Harley-Davidson is shipping 4 new 5/16-18 x 2 in. socket head screws and 4 new 5/16-18 nuts for each kit. The heads of these screws are marked "H-D GRD 8". The kit number for the screws and nuts is 93713.

Socket Head Screw Comparison

1. Remove the 5/16-18 x 2 in. socket head screws and 5/16-18 nuts.

2. Install the new 5/16-18 x 2 in. socket head screws and 4 new 5/16-18 nuts

3. Tighten the screws to 14-18 ft-lbs torque.
