SERVICE BULLETIN

M-1048

November 21, 1994

MODEL 1340cc JACKSHAFT RUNOUT

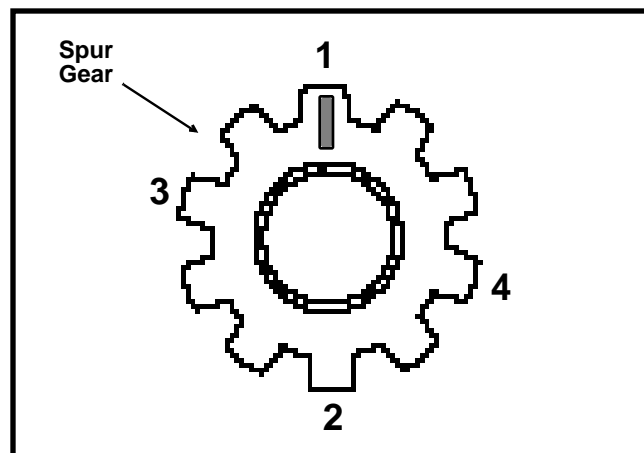
Figure 1. Check Jackshaft Runout - Method 1

1. Select any tooth on the jackshaft spur gear and mark the face as shown in Figure 1, position 1.
2. Place the jackshaft seal surface in a lathe or V-block.
3. Check the runout in four positions (as shown in Figure 1) using a dial indicator on the tooth tips.
4. Refer to Final Instructions.

1. Select the largest and the smallest of the four clearance/indicator readings. Subtract the smallest number from the largest.
 - a. If the remainder is less than 0.007 inch (0.178 mm), the jackshaft is not the cause of seal leakage. Replace the oil seal (HD Part No. 12066).
 - b. If the remainder exceeds 0.007 inch (0.178 mm), then the jackshaft runout is excessive. Replace both the jackshaft (HD Part No. 33127-94) and the oil seal (HD Part No. 12066).
2. Install a **new** oil seal in the inner primary chaincase cover. Be sure to install the seal to the correct depth. See Primary Chaincase, Cleaning, Inspection and Repair, in Section 6 of the Service Manual.

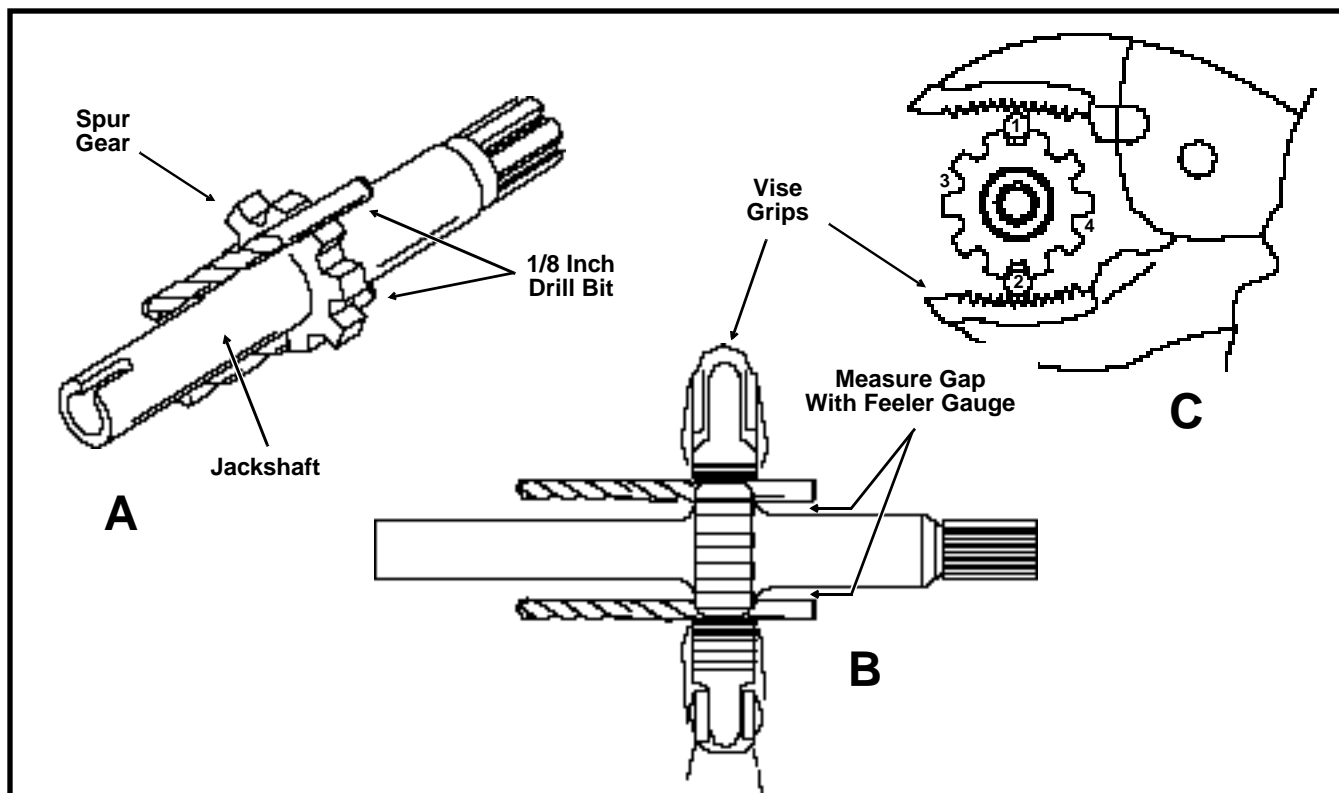
Figure 2. Check Jackshaft Runout - Method 2

1. See A in Figure 2. Place a 1/8 inch diameter drill bit in the root between two teeth on the spur gear. Place a second 1/8 inch diameter drill bit in the root 180° from the first location. Using a vise grips, lock the bits in place.
2. Use a feeler gauge to measure the gap between each bit shank and the jackshaft seal surface. See B in Figure 2. Record both clearances. Release the vise grips and remove the drill bits.

3. Place a drill bit in the root approximately 90° from the location where the second measurement was performed. See C in Figure 2. Place the second drill bit in the root 180° from this location. Lock the bits in place with the vise grips.
4. Use a feeler gauge to measure the gap between each bit shank and the jackshaft seal surface. Record both clearances. Release the vise grips and remove the drill bits.
5. Refer to Final Instructions.
