SERVICE BULLETIN

M-1060 November 19, 1996

1997 SUPPLEMENTAL SERVICE INFORMATION BULLETIN

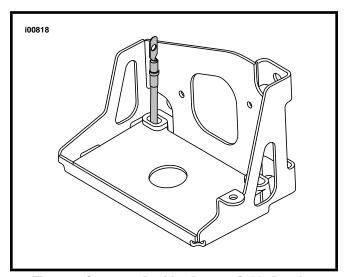
Figure 2. Sportster Positive Battery Cable Routing

The positive battery cable on Sportsters is shipped loose outside the battery box and must be routed up through the hole in the rubber tray liner before being connected to the battery. Do not route cable around the outside of the battery box, or through the opening in the side of the battery box.
