SERVICE BULLETIN

M-1067

June 13, 1997

ELECTRONIC CONTROL MODULE (ECM) RECALIBRATION (PRODUCT PROGRAM NO. 5)

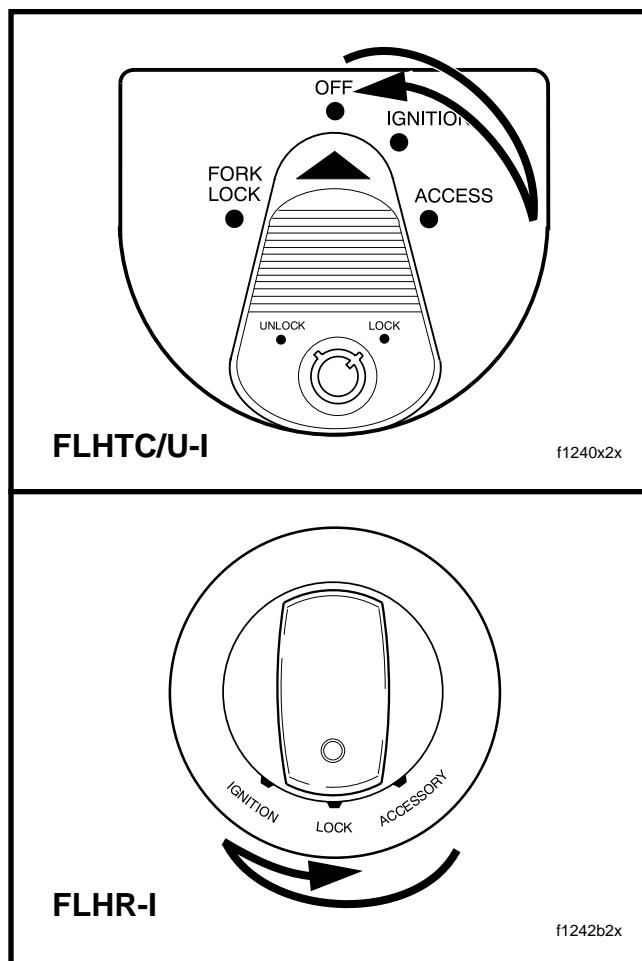
Figure 1. Ignition/Light Key Switch

Harley-Davidson has learned that the batteries of 1997 fuel injected vehicles may discharge with the Ignition/Light Key Switch in the OFF (FLHTC/U-I) or LOCK (FLHR-I) position. This condition only occurs when the ECM receives a very brief pulse of battery voltage as a result of the switch being in the IGNITION position momentarily. Such pulses can be received by the ECM as follows:

- The Ignition/Light Key Switch is turned to the ACCESS(ORY) position and then returned to OFF momentarily stopping in the IGNITION position. See upper frame of Figure 1.

- The Ignition/Light Key Switch is turned to the IGNITION position and then rapidly returned to LOCK. This may occur if the operator momentarily overshoots the LOCK position while turning the knob from ACCESS(ORY). See lower frame of Figure 1.

Until the problem is rectified through the appropriate dealer contact, owners also should be advised that the problem can be avoided by leaving the Ignition/Light Key Switch in the IGNITION position at least until the Check Engine Lamp becomes extinguished.
