SERVICE BULLETIN

M-1075

Safety Recall Code 093

P&A Custom Horn Cover Part No. 69528-98

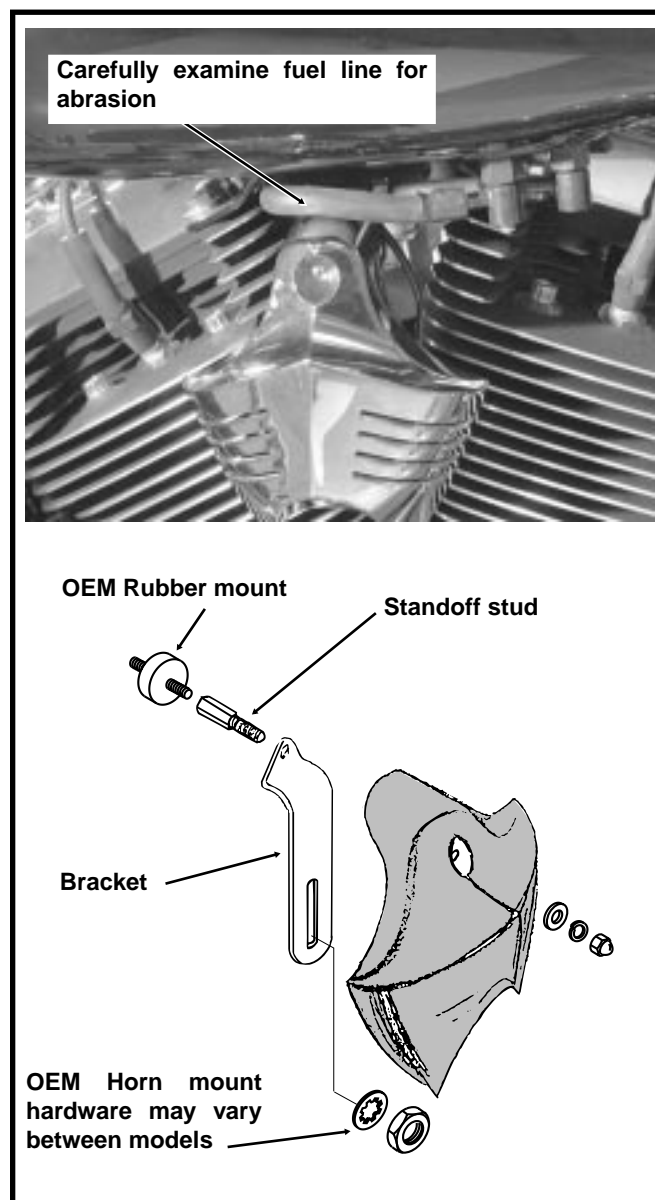
Figure 1.

Harley-Davidson has determined that abrasion, leading to possible fuel leakage, can occur between the fuel line and the accessory custom horn cover, Part Number 69528-98. Fuel leakage could lead to personal injury.

Figure 1 shows the horn installation on an EFI equipped motorcycle. Since this is a Multi-fit kit, the installation will vary on different models. ALL FUEL LINES, REGARDLESS OF MODEL, MUST BE CAREFULLY EXAMINED FOR CHAFING AND/OR ABRASION.

1. Remove acorn nut and custom horn cover.
2. Remove mounting bracket and standoff stud from OEM Rubber mount.
3. Examine fuel line for abrasion. If fuel line shows evidence of abrasion/contact it MUST BE REPLACED. Consult appropriate Service Manual.

4. Install OEM horn and bracket assembly. Consult appropriate Service Manual.
