SERVICE BULLETIN

M-1077 November 16, 1998

1999 FLT FUEL TANK AND VOLTAGE REGULATOR HARNESS SET-UP

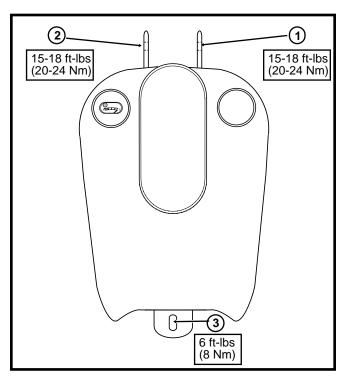
Figure 1. Fuel Tank Fastener Tightening Sequence

On certain 1999 FL models manufactured and shipped between August and November 1998, the fuel tank may be offset and tilted to the right side of the bike. This offset is more obvious on the FLHR/CI models. This was the result of variances in production processes. The issue has since been corrected, but vehicles shipped during the above mentioned period may have a misaligned fuel tank. Please inspect all unsold FL model motorcycles at your dealership that were shipped between August and November 1998 for correct fuel tank-to-frame alignment. Also inspect delivered 1999 FL vehicles at the next scheduled service.

- Remove seat. See SEAT, REMOVAL in Section 2 of current FLT Service Manual.
- See Figure 1. Loosen console acorn nut (FLHR/CI) or allen head screws (all other FL models).
- 3. Loosen right front fuel tank fastener.
- 4. Loosen left front fuel tank fastener.
- 5. Loosen rear fuel tank tab fastener.
- With tank aligned on frame, check right front tank mount to make sure it is straight (parallel to mounting tunnel). Straighten right tank mount as required.

The following tightening sequence, as listed below, must be followed to ensure proper fuel tank to frame alignment. An assistant may be required to hold the tank in alignment with the frame while tightening the fasteners.

- 7. Tighten right front fastener to 15-18 ft-lbs (20-24 Nm).
- 8. Tighten left front fastener to 15-18 ft-lbs (20-24 Nm).
- 9. Tighten rear tab fastener to 6 ft-lbs (8 Nm).
- Position console on fuel tank for best appearance and tighten acorn nut to 80-100 in-lbs (9-11 Nm) (FLHR/CI) or allen head screws (all other FL models).
- Install seat. See SEAT, INSTALLATION in Section 2 of current FLT Service Manual.

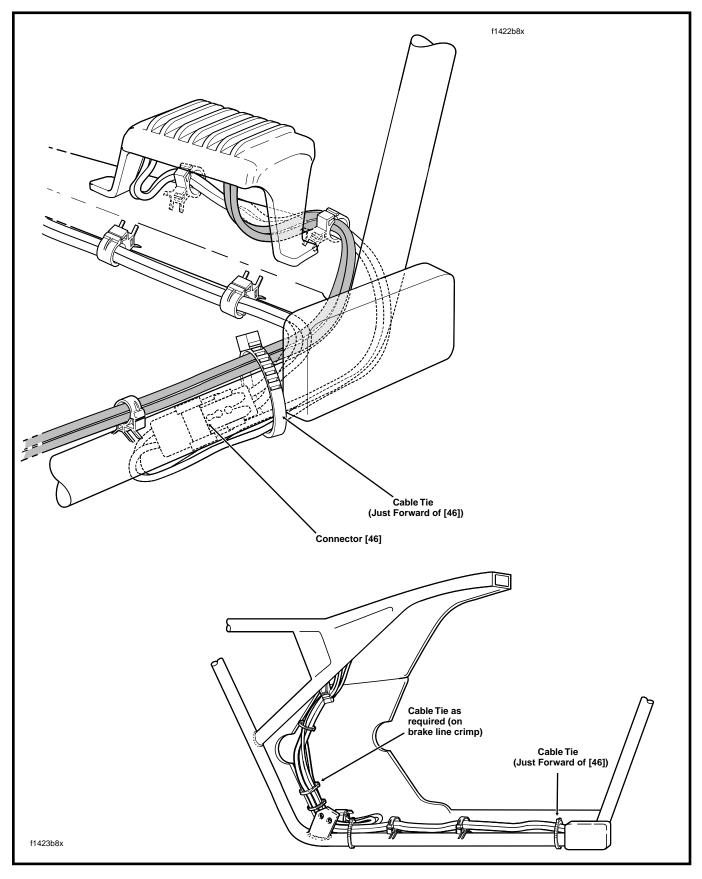
Figure 2. Voltage Regulator Cable Routing

Insufficient clearance between voltage regulator wires and powertrain will result in wire insulation being worn away over time and electrical problems with motorcycle. Cable tie wires to frame tube as required to provide for adequate clearance. Failure to comply will result in equipment damage.

- 1. See Figure 2. Inspect the voltage regulator wiring harness routing forward of connector [46]. Make sure wiring harness is tucked up close to frame tube to prevent possible damage from road debris or powertrain movement. Inspect voltage regulator wiring harness routing behind connector [46]. There is a machined surface on the bottom of the crankcase under the cam cover just to the rear of the connector. Make sure sufficient clearance exists between sharp edge of machined surface and voltage regulator wires. Cable tie top wires (by machined edge) and four lower wires forward of connector to frame tube as shown in upper illustration of Figure 2.

- 2. Inspect voltage regulator wiring harness routing just behind oil dipstick cover. Make sure enough clearance exists between voltage regulator wires and rear oil dipstick cover bottom socket head screw. Make sure wires are not between brake line and oil dipstick cover screw. Move wires behind brake line and cable tie wires to crimp in brake line (just under brake line clip) as required to provide adequate clearance. Do not overtighten cable tie on brake line.
