## **SERVICE BULLETIN**

M-1086 Safety Recall Code 099

# 1998 MODEL YEAR SIDE CAR AXLE

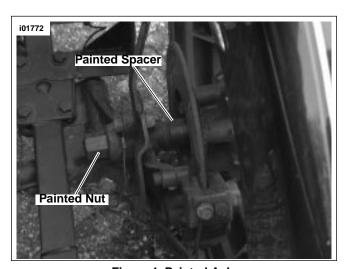
Figure 1. Painted Axle

- 1. Inspect the axle and axle nut on your side car.
  - See Figure 1. If you have an axle with a painted spacer and hex nut, proceed to the Axle Replacement instructions in this Service Bulletin.
  - See Figure 2. and Figure 3. If you have a stainless axle and hex nut, you do **not** need to replace the axle or hex nut. Proceed to the Credit Procedure instructions in this Service Bulletin.

- If you have a painted spacer and hex nut, as identified in Figure 1. (Axle Inspection and Identification), raise and block side car chassis high enough to allow wheel removal.
