SERVICE BULLETIN

M-1116

September 10, 2001

ENGINE SPROCKET NUT

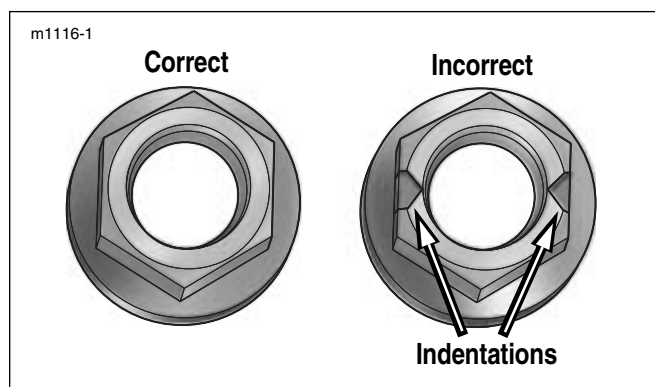
Figure 1. Engine Sprocket Nut

The purpose of this bulletin is to notify dealers that some Sportster motorcycles were produced with incorrectly manufactured engine sprocket nuts. The incorrectly manufactured nut has an interference fit which may result in a false torque reading. This can cause the nut to lose clamp load on the engine sprocket, allowing the sprocket and alternator rotor to loosen and create noise.

See [Figure 1](#). A good, serviceable sprocket nut is shown on the left side of the figure. An incorrectly manufactured nut is shown on the right, identified by two arrow-shaped indentations on the face of the nut.

If an affected motorcycle has been brought in for repair and the primary cover is removed, inspect the engine sprocket nut. Replace if it is determined to be an incorrectly manufactured nut.
