SAFETY RECALL CAMPAIGN 0105 UPDATE

SERVICE BULLETIN

M-1119

FRONT FENDER TIP LAMP JUMPER HARNESS RETENTION

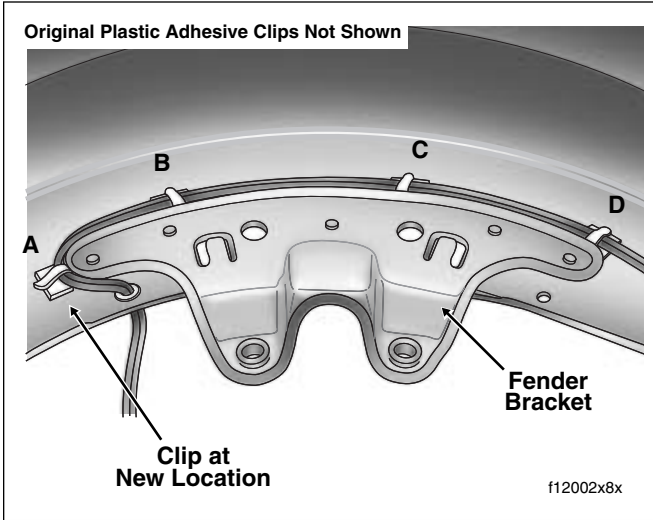
Figure 1. Left Side Front Fender Well

While location A is new, locations B, C and D are evenly spaced near or beside the existing plastic adhesive clips.

If any portion of the jumper harness crosses over the riveted fender bracket, contact with the tire can cause chafing or other damage. Damage to the wiring can lead to loss of lighting while riding, which could result in death or serious injury.

If the height of any metal clip is above the riveted fender bracket, contact with the tire can cause damage that results in premature tire failure, which could result in death or serious injury.

5. Obtain Kit #93950 if no damage to the original jumper harness was observed. Obtain Kit #93951 if any damage is present.
6. Remove jumper harness, if damaged. See Section 8.14 FENDER TIP LAMPS, FRONT FENDER TIP LAMP JUMPER HARNESS, REMOVAL.
7. Install four **new** metal adhesive clips as follows:
- a. Using a soapy cleaning pad, such as Scotch Brite®, thoroughly scrub fender well at locations A, B, C and D as shown in Figure 1.

- b. Rinse with clear water and dry areas with a clean white cloth. Repeat step until clean cloth shows no evidence of dirt.
 - c. Swab areas with denatured alcohol.
 - d. Remove paper backing to expose adhesive and firmly press clips into place.
8. If any damage to the original jumper harness was observed, install **new** harness from Kit #93951. See Section 8.14 FENDER TIP LAMPS, FRONT FENDER TIP LAMP JUMPER HARNESS, INSTALLATION.
9. Route the wires of the jumper harness through the four new metal adhesive clips added in step 7.
10. Verify that jumper harness is now properly routed through one weld clip, four new metal adhesive clips, and as many as three original plastic adhesive clips.

11. Verify that no portion of the jumper harness crosses over the riveted fender bracket.

12. Using finger pressure, bend arm of each clip down over wires so that no portion of the clip is above the height of the fender bracket.
13. Install front wheel. See Section 2.2 FRONT WHEEL, INSTALLATION.
14. Insert bolt through battery negative cable (black) into threaded hole of battery negative (-) terminal. Tighten bolt to 60-96 **in-lbs** (6.8-10.9 Nm).
15. Install seat. See Section 2.21 SEAT, INSTALLATION.
