SERVICE BULLETIN

M-1135

April 08, 2003

Ignition Switch Cover Concerns

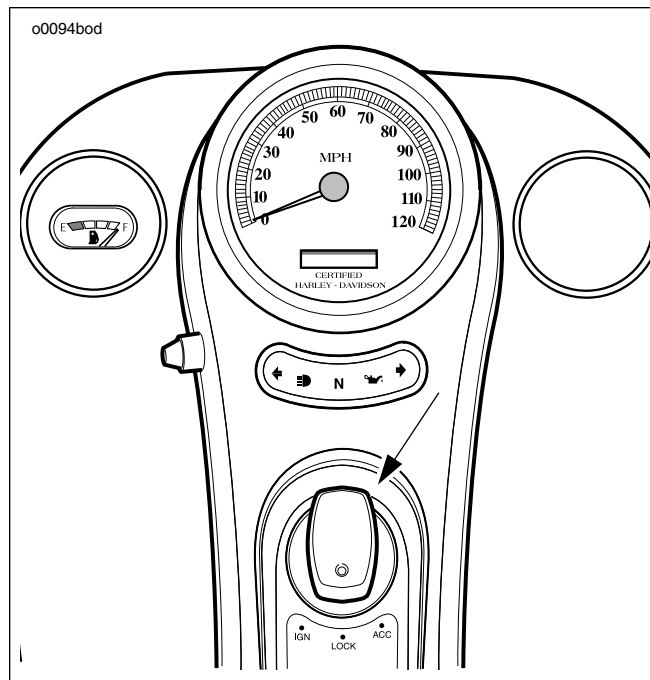
Figure 1. Ignition Switch

Harley-Davidson has learned that there may be an issue with the ignition switch cover not staying in the closed position on certain vehicles featuring a fuel tank console mounted ignition switch. A revised switch is now available by ordering part number 71313-96A.

If a customer identifies this issue with their vehicle, replace the switch with the revised switch assembly.

1. Remove and replace ignition switch. See service manual.
