SERVICE BULLETIN

M-1143

November 11, 2003

2004 SPORTSTER OIL TANK VENT HOSE ROUTING PRODUCT PROGRAM NO. PP9

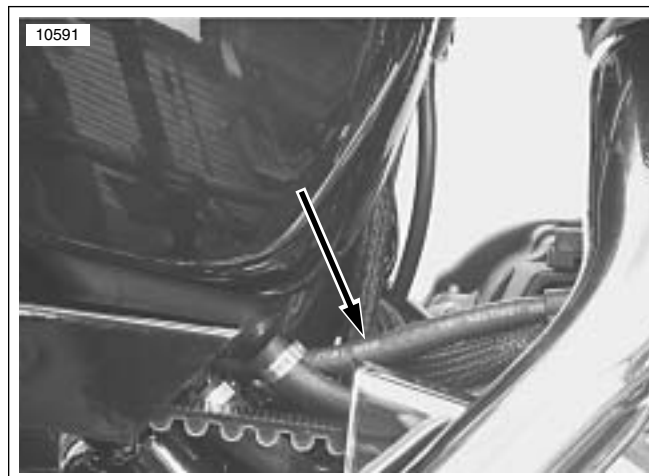
Figure 1. Correct Oil Tank Vent Hose Routing

See Figure 1. If oil tank vent hose is routed correctly (i.e., just above return hose and even with bottom of oil tank), no further action is required.

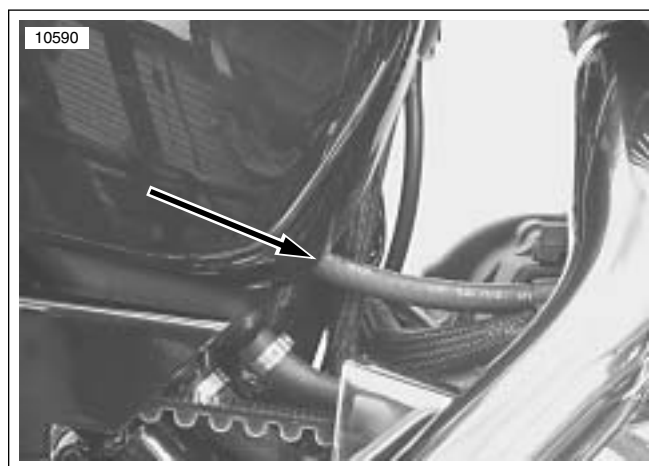
Figure 2. Incorrect Oil Tank Vent Hose Routing

Some oil tank vent hoses may have been incorrectly routed during assembly. This may result in a pinched hose which does not allow adequate venting of the oil tank.

See Figure 2. If oil tank vent hose is routed high (i.e., up behind oil tank), it must be repositioned as follows:

1. Remove left side cover, maxi-fuse, seat and ignition control module (ICM).
2. Remove filler cap/dipstick, right side cover and rear belt guard.
3. Remove fasteners securing oil tank to frame. Shift oil tank toward the right side of the vehicle to gain access to the oil tank vent hose.

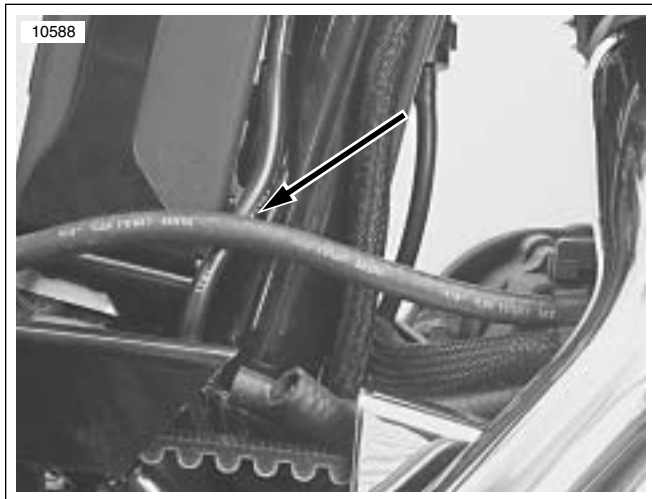
**Figure 3. Oil Tank Vent Hose Pinch Point
(Oil Tank Removed for Clarity)**

See Figure 3. This figure shows the area where the oil tank vent hose may be pinched between the oil tank and the negative battery cable and battery tray.
