SERVICE BULLETIN

M-1151A

Safety Recall Code 0113

MAIN CIRCUIT BREAKER REPLACEMENT

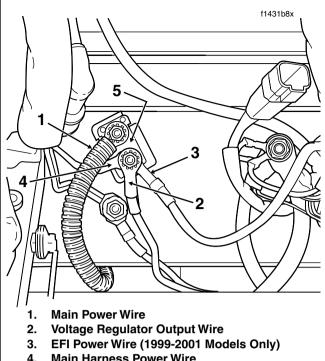
Figure 1. Upper Frame Crossmember (Under Seat)

- Main Harness Power Wire
- Main Circuit Breaker

- Locate main circuit breaker on left side of upper frame crossmember. See Figure 1.
- Remove Keps nut from copper post. Remove main power wire ring terminal (with convoluted tubing).
- Remove Keps nut(s) from silver post. Remove voltage regulator output, EFI power (1999-2001 models only) and main harness power wire ring terminals.
- Bend tab on mounting clip outward and remove main circuit breaker.

- Install new 50 amp main circuit breaker into mounting clip oriented with the copper post topside. See Figure 1.
- Install main harness power, EFI power (1999-2001 models only) and voltage regulator output wire ring terminals onto silver post. Start Keps nut on post.

- Place main power wire ring terminal (with convoluted tubing) onto copper post and start Keps nut.
- Alternately tighten Keps nuts to 20-35 in-lbs (2.3-4.0 4. Nm).
- Place the battery into the battery box, terminal side forward.
