### SERVICE BULLETIN

M-1153

Safety Recall Code 0114

### RECALL CODE 0114 - TAILLAMP BULB REPLACEMENT

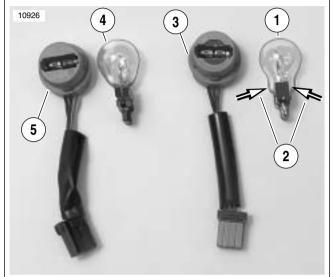
Figure 1. Taillamp Bulbs And Socket Assemblies

As recently advised in ML-391, Harley-Davidson has identified an issue with the taillamp bulb on certain motorcycles. See Figure 1. The existing taillamp bulb could become loose in the socket and render tail light and brake light inoperative.

- 1. Bulb that must be replaced
- 2. Area of interference in socket (5)
- 3. Socket with reliefs
- 4. Replacement bulb
- 5. Socket without reliefs

See Figure 1. Bulb (1) will only fit socket (3). Bulb (4) will fit both sockets (3) and (5).

In the interest of motor vehicle safety and customer satisfaction, Harley-Davidson has elected to initiate a voluntary recall (Campaign 0114) to replace the taillamp bulb on all affected motorcycles. See REQUIRED DEALER ACTION to perform the recall service.

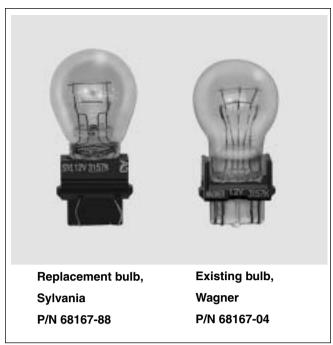
Figure 3. Taillamp Bulbs

See Figure 3. Both bulbs in Figure 3 were identified as Part No. 68167-88. In January, 2004, the Wagner bulb with the filament support was changed to Part No. 68167-04. Make certain dealer technicians and parts personnel use the correct bulb for future bulb replacements.

See Figure 3. Identify any bulbs in your dealer parts inventory which are the Wagner design and are labelled with the earlier 68167-88 Part No. Relabel these bulbs as Part No. 68167-04 and relocate in an appropriate bin location.
