SERVICE BULLETIN

M-1171

Safety Recall Code 0120

ANTI-LOCK BRAKE SYSTEM (ABS) BRAKE LINE ROUTING

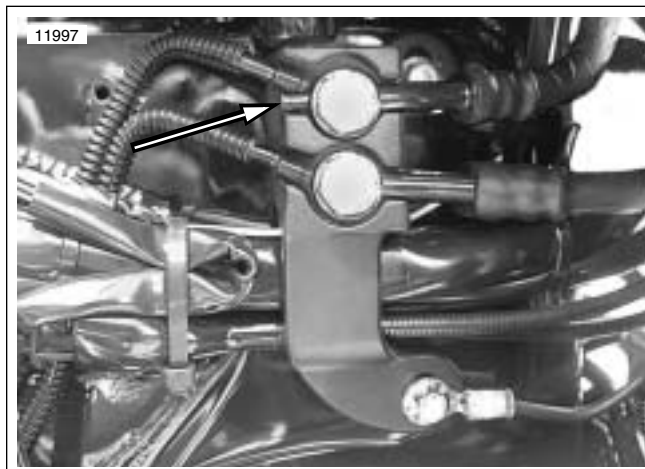
Figure 1. Correct Routing For Forward Brake Lines

1. See Figure 1. Routing is correct when both brake lines extending forward from the brake manifold are installed outboard of the rear facing lines and the front calipers brake line, with nipple, is installed in the upper manifold port.

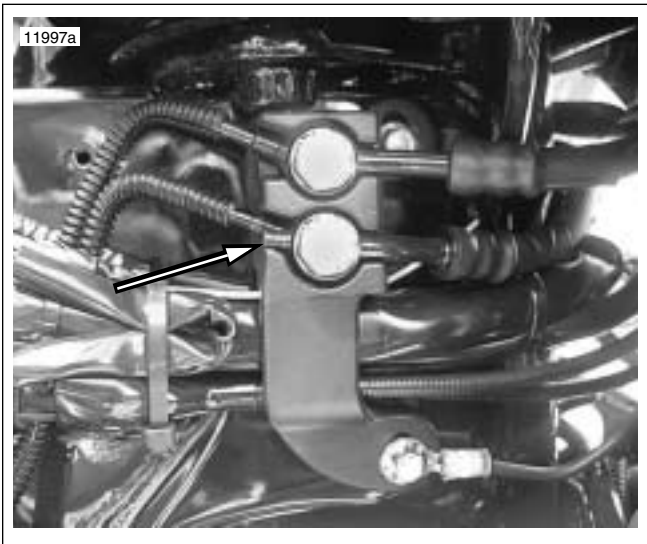
Figure 2. Incorrect Routing For Forward Brake Lines

2. See Figure 2. Routing is incorrect when the front calipers brake line, with nipple, is installed in the lower manifold port.

If either incorrect routing condition is present, remove the banjo bolts at the manifold, reposition the brake lines correctly and install the banjo bolts with **new** brake line gaskets, Part No. 41731-01. Bleed the brake system according to FLT Police Models Service Manual Supplement.

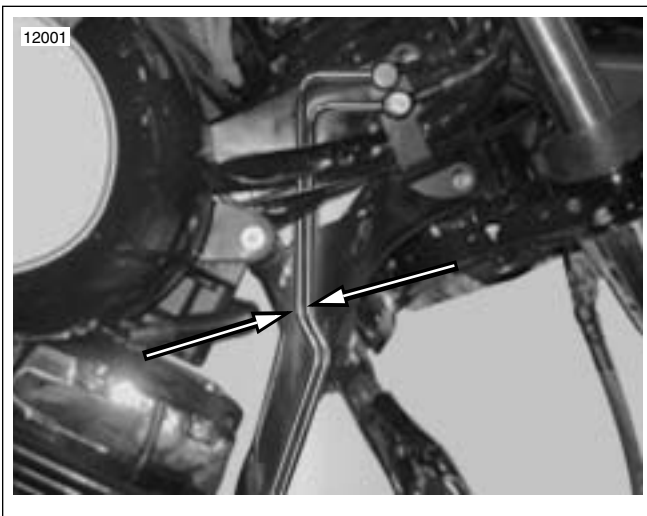
Figure 3. Correct Routing For Rearward Extending Brake Lines

1. See Figure 3. Routing is correct when both brake lines extending rearward from the brake manifold are evenly routed as they are followed down from the brake manifold.

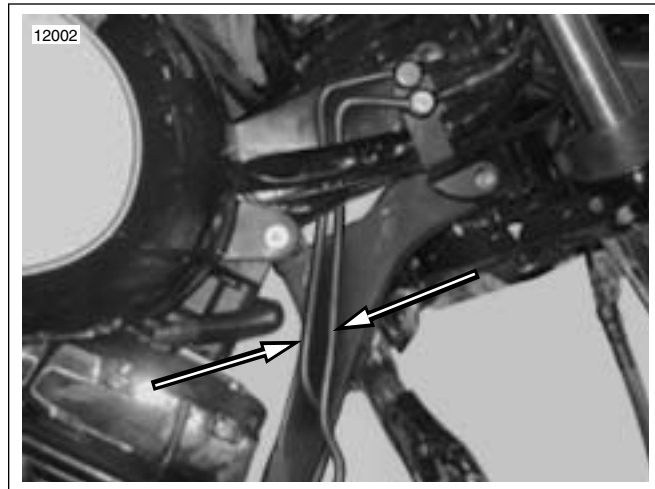
Figure 4. Incorrect Routing For Rearward Extending Brake Lines

2. See Figure 4. Routing is incorrect when both brake lines extending rearward from the brake manifold are uneven leaving large gaps and crossing each other where bends occur.
