# SERVICE BULLETIN

M-1176A

## ADVANCED AUDIO SYSTEM SOFTWARE UPDATE

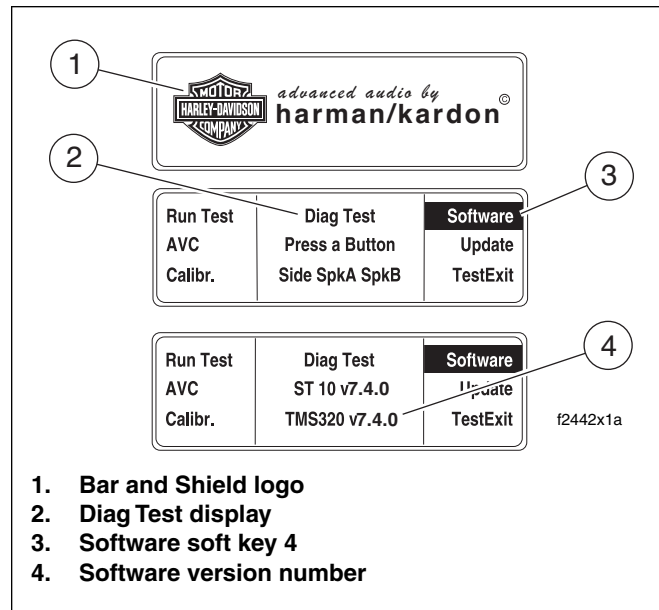
Figure 1. Identify Software Version Number

1. Turn the ignition/headlamp key switch to OFF.
2. Simultaneously press and hold any two soft keys (1, 2, 3, 4, 5, or 6).
3. Turn the ignition/headlamp key switch to ACCESS.
4. See Figure 1. Continue to hold the two soft keys while the Harley-Davidson Bar and Shield logo (1) is displayed. The display will cycle to Diag Test (2).
5. Press the Software or number 4 soft key (3) to display the software version number (4).
  - a. If the software version number is lower than 7.8.0, Update Receiver Software with the v7.8.0 update CD.
  - b. Receivers with v7.8.0 or higher will not need to be updated.
