## FLHTCSE<sup>2</sup> TOUR-PAK INTERIOR LIGHT REPLACEMENT Product Program P14

Complete an electronic warranty claim referencing Service Bulletin M-1188. Based upon the type of claim, fill in the rest of the form as follows:

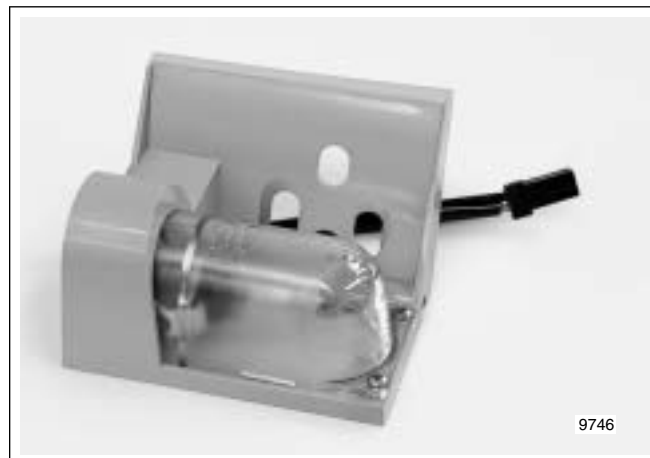
On certain 2005 FLHTCSE<sup>2</sup> model motorcycles, failure of the mechanical switch may cause the Tour-Pak interior light to stay on when the lid is closed, possibly resulting in battery drain.

Figure 1. Mechanical Switch Tour-Pak Interior Light  
(P/N 54302-98A )

*It is difficult to visually distinguish the earlier style mercury switch light from the later style mechanical switch light. To determine switch type, first open the Tour-Pak to illuminate the interior light. Lightly tap the light, and if it flickers, it is the ball in the mechanical switch breaking contact- replace the light. If the light does not flicker, but remains steady, then it is the mercury switch type, and the light should **NOT** be replaced.*

In the interest of customer satisfaction, Harley-Davidson has elected to replace the old style mechanical switch (P/N 54302-98A) with the LED (P/N 54332-04) on all affected motorcycles. See REQUIRED DEALER ACTION to perform the replacement procedure.

Remove the mechanical switch type Tour-Pak interior light and install the LED. Exercise care to avoid replacing mercury switch type lights as they are not subject to this program. See IMPORTANT NOTE which follows. Replacement LED style lights that may already have been installed also are not included.
