# SERVICE BULLETIN

M-1206

April 9, 2007

## 2007 SPORTSTER ELECTRICAL DIAGNOSTIC MANUAL UPDATE

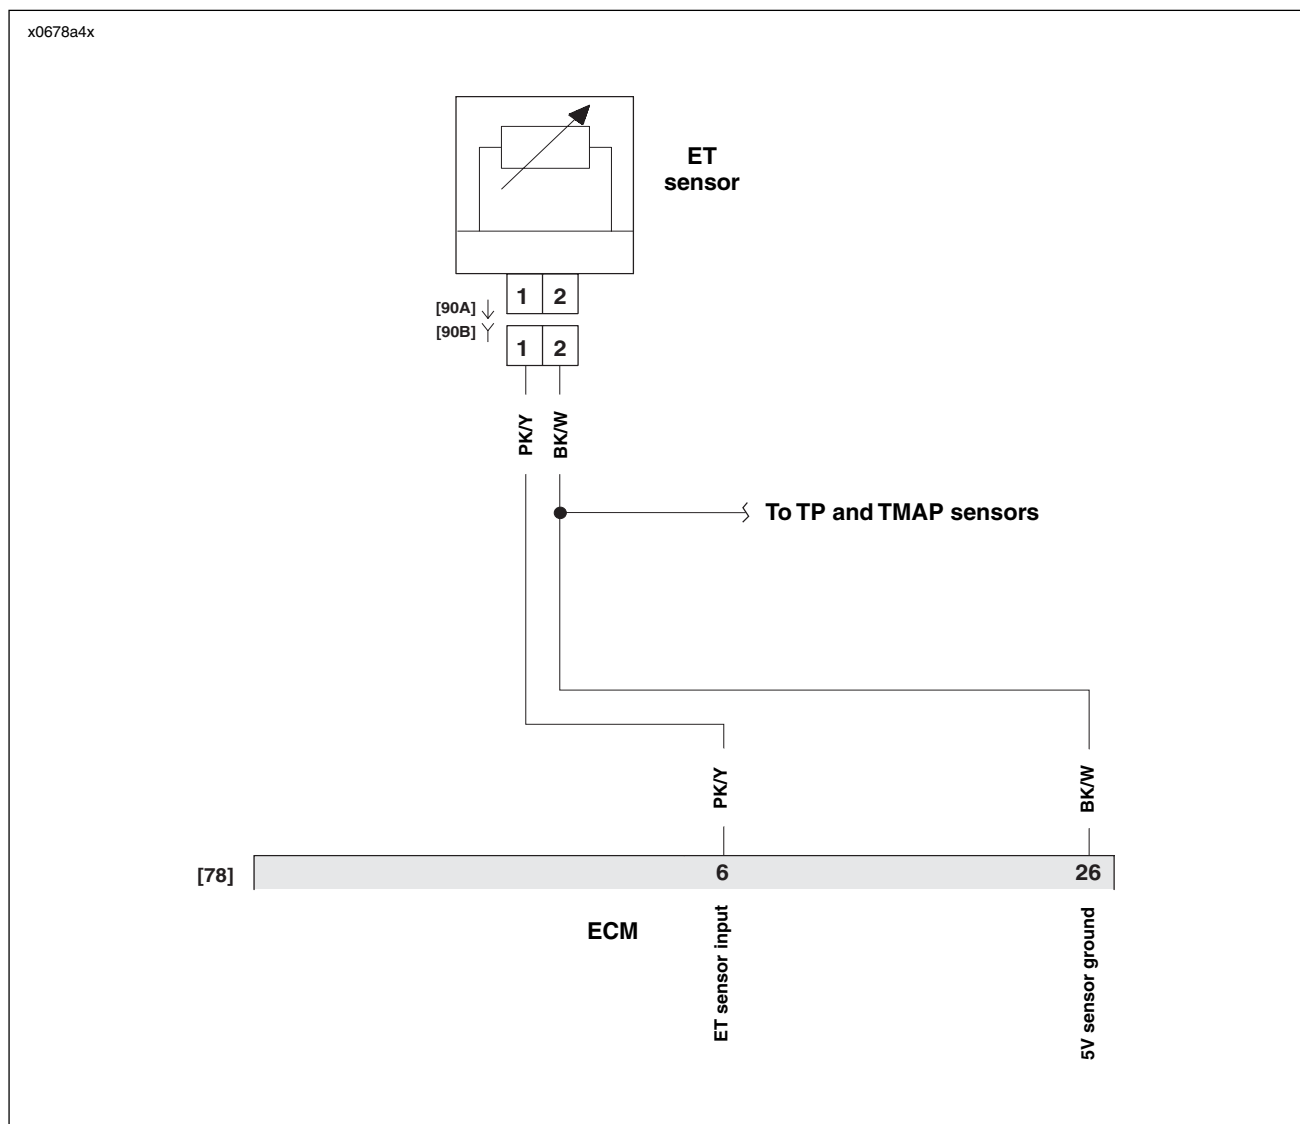
**Figure 4-40.ET Sensor Circuit**

Several running changes were made to the electrical system of 2007 XL models produced on or after 1/31/2007 (see service bulletin M-1203 for a detailed list of changes). One of the changes moved the Engine Temperature (ET) sensor connector [90] from the engine sub-harness to the main harness. The changes listed in the next step apply **only** to vehicles produced on or after 1/31/2007.

- Replace Figure 4-40 with the figure below.
- Delete the last row ([145] Engine Harness) from Table 4-23.

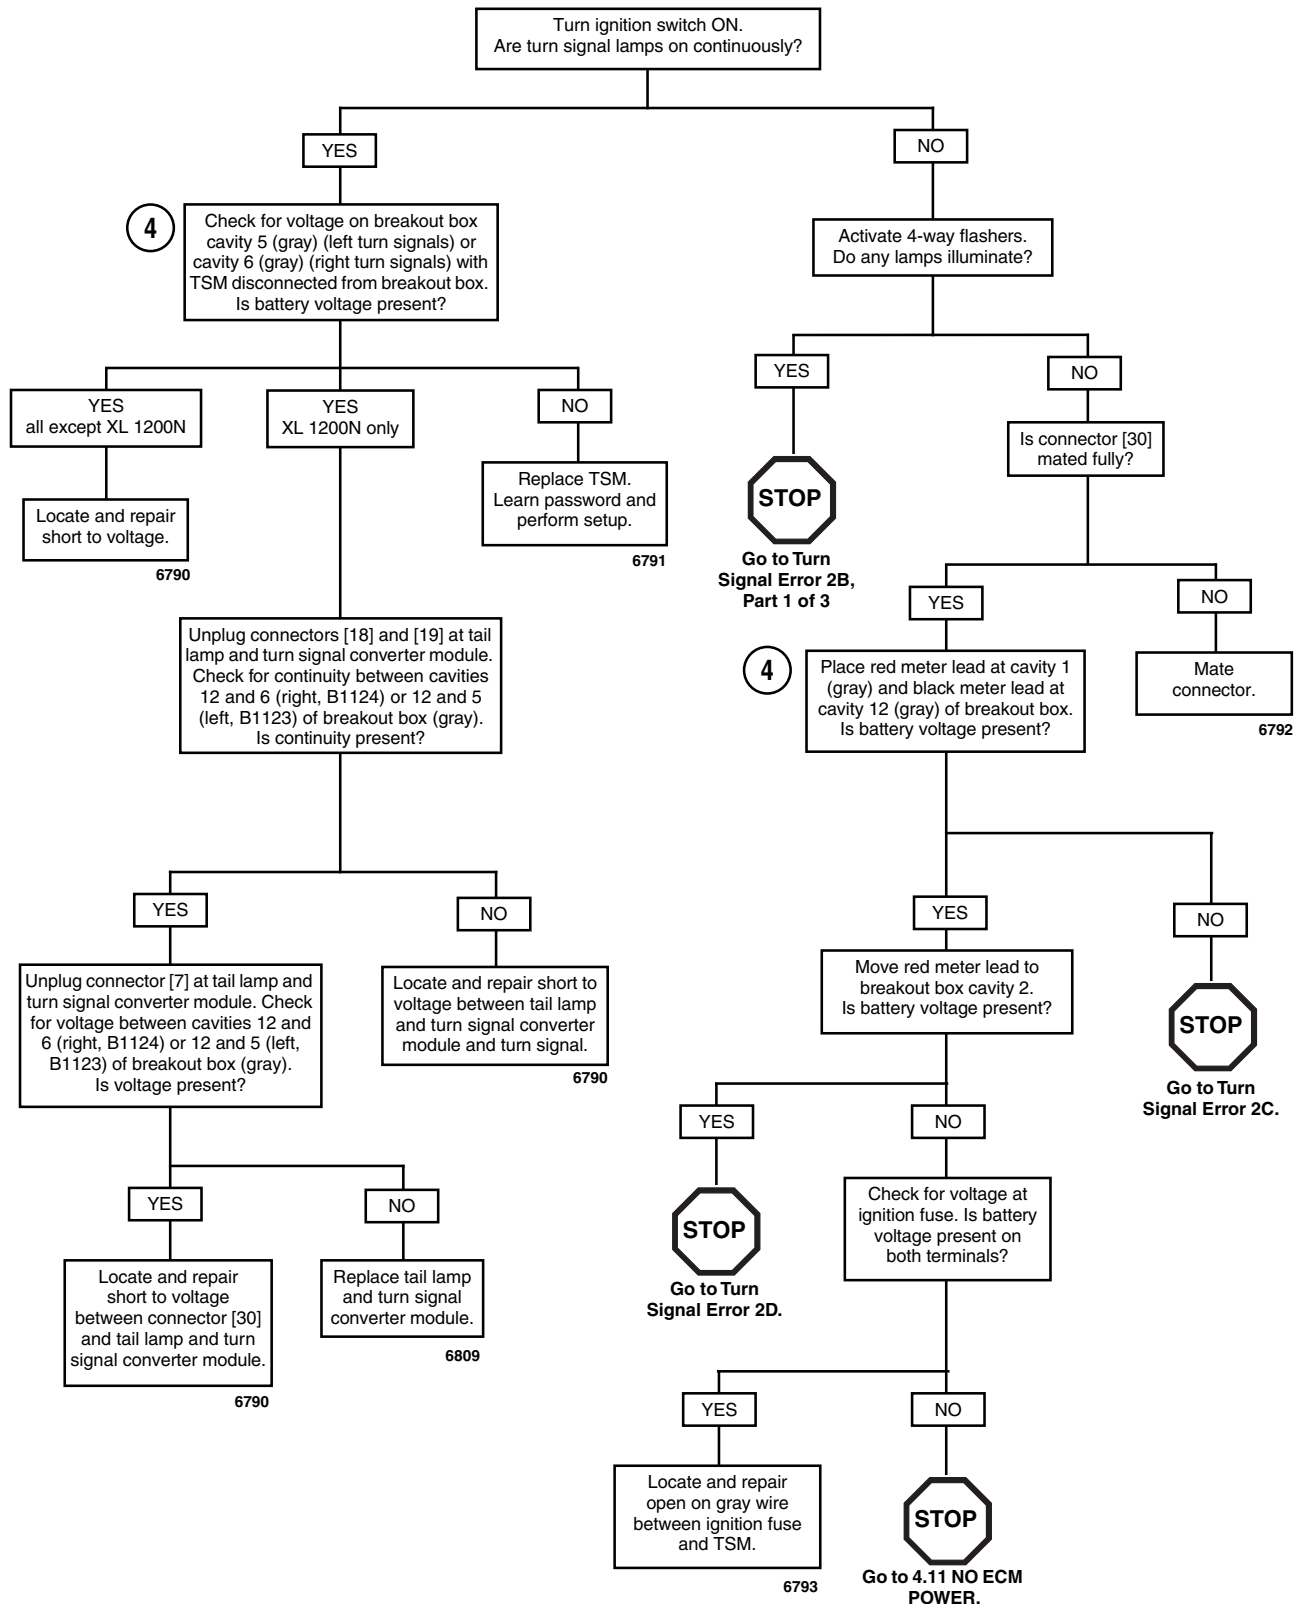
## Turn Signal Error 2A

**WILL NOT FLASH, 4-WAY FLASHERS INOPERABLE: DTC: B1121, B1122, B1141**

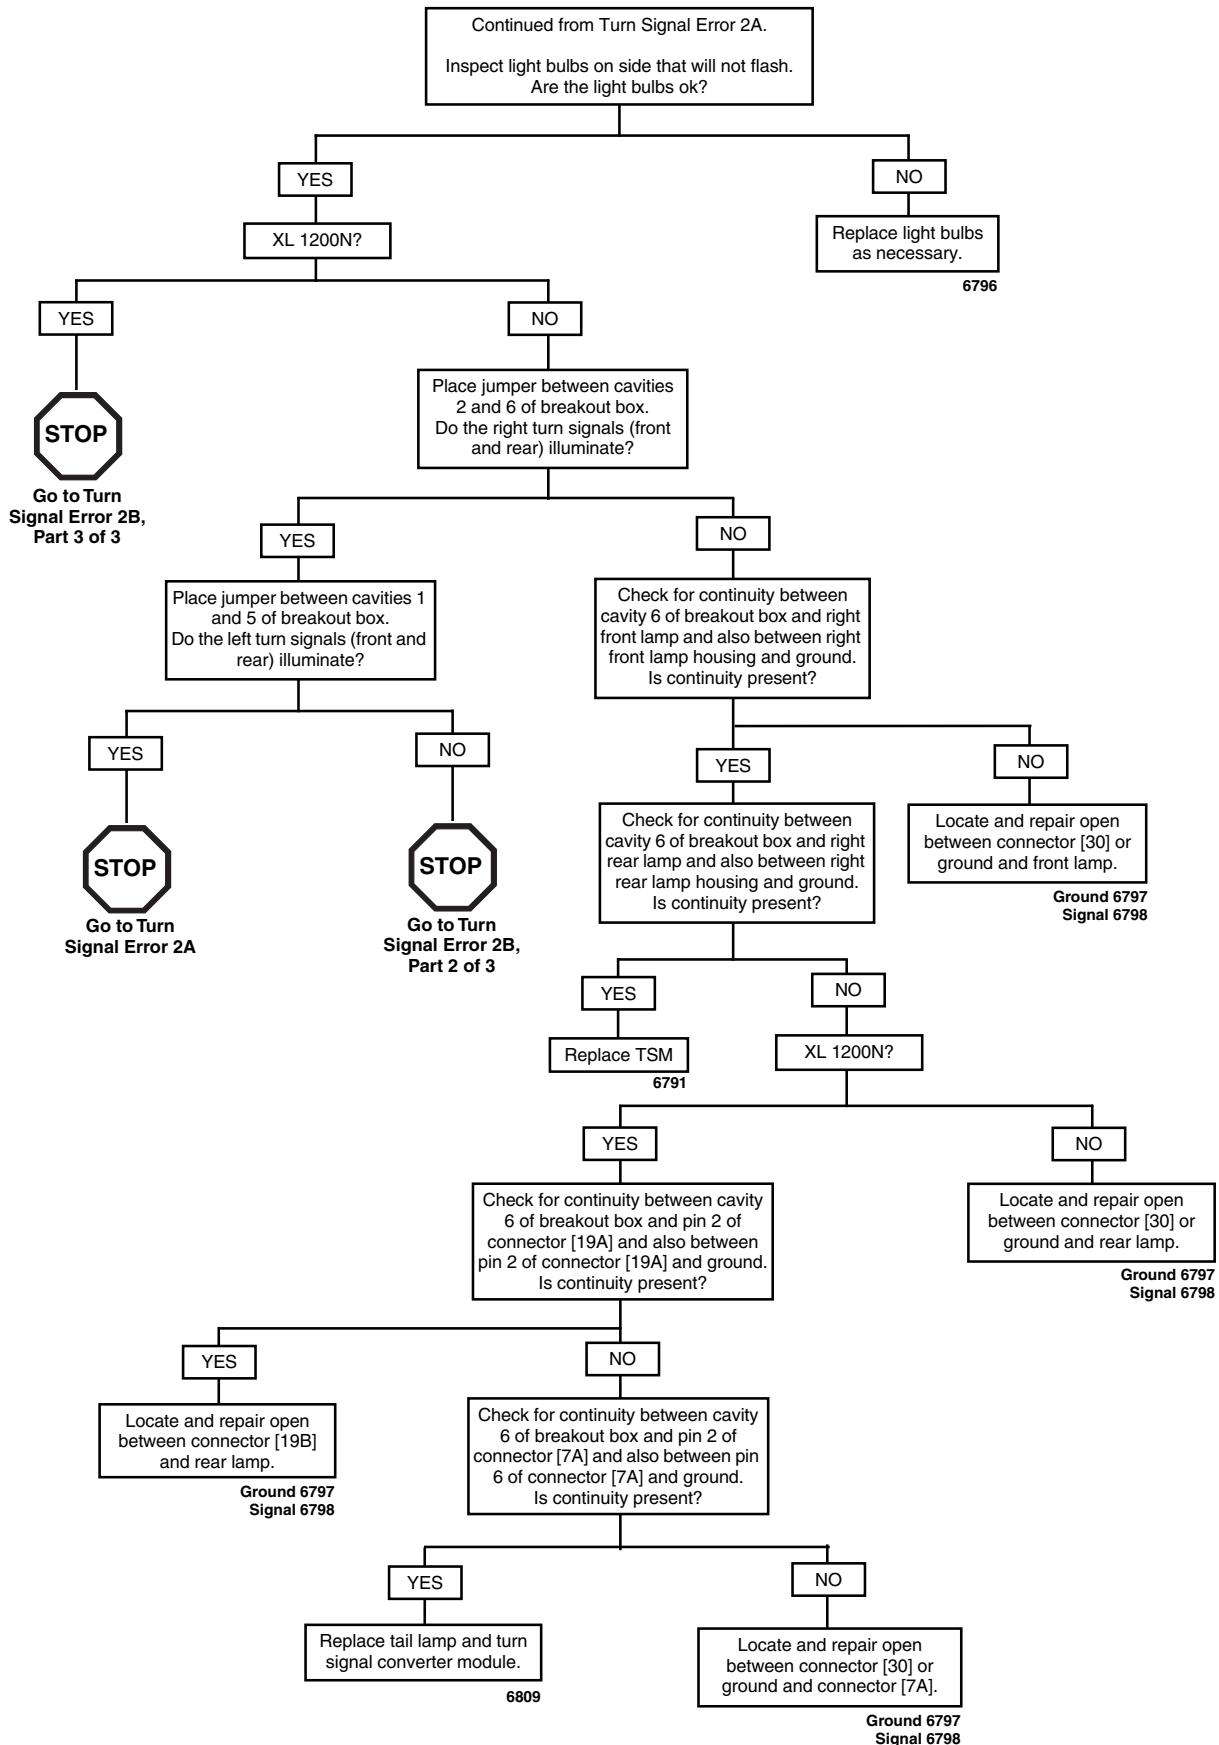
## Turn Signal Error 2B, Part 1 of 3

WILL NOT FLASH, 4-WAY FLASHERS INOPERABLE: DTC: B1121, B1122, B1141

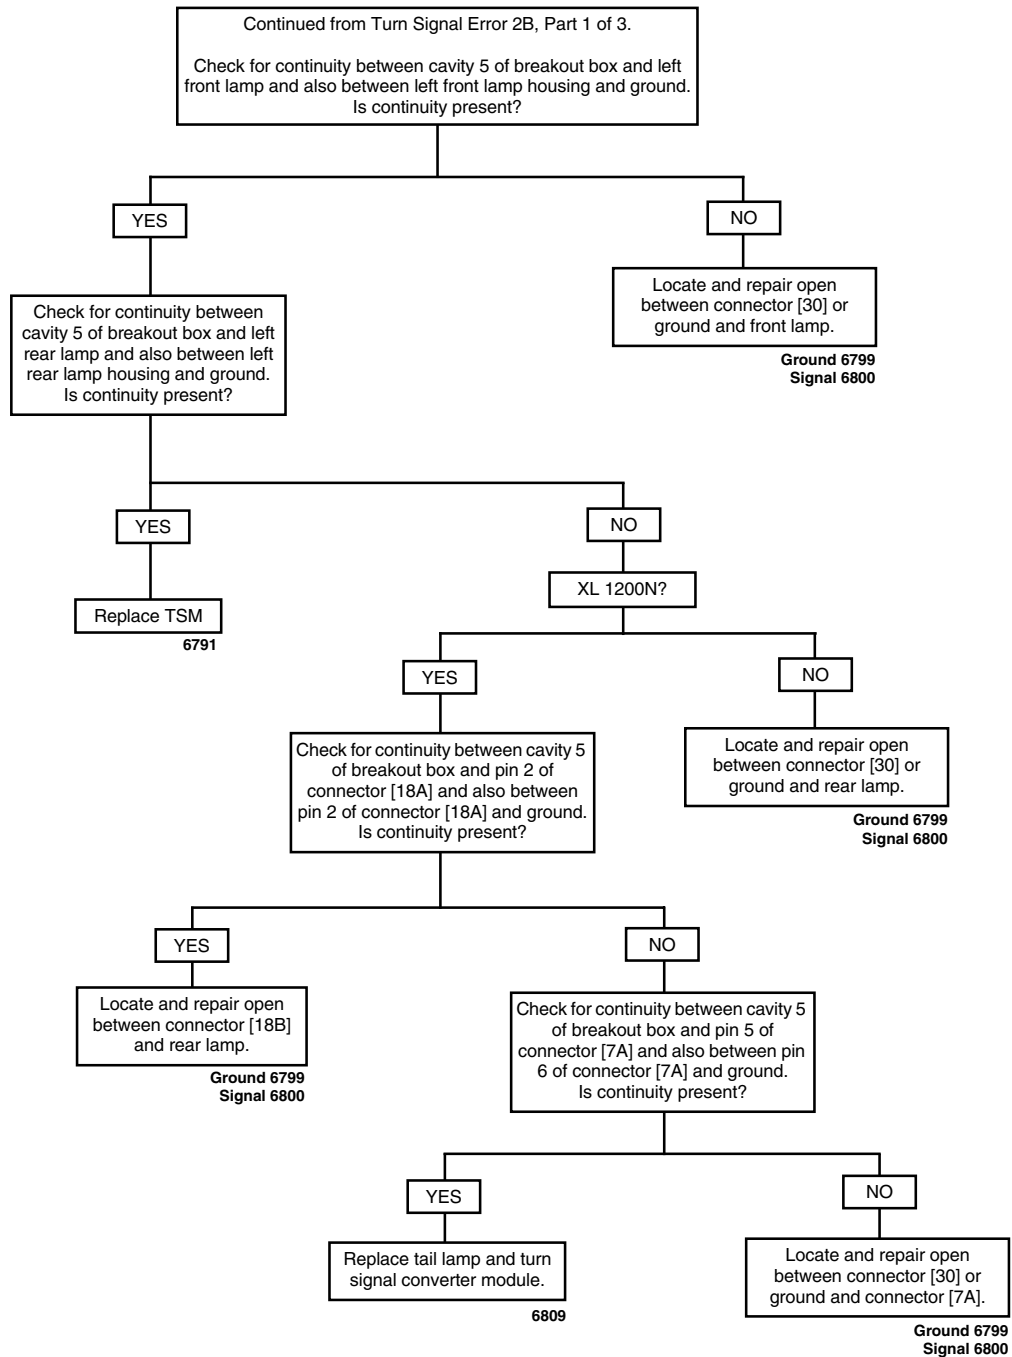
## Turn Signal Error 2B, Part 2 of 3

**WILL NOT FLASH, 4-WAY FLASHERS INOPERABLE: DTC: B1121, B1122, B1141**

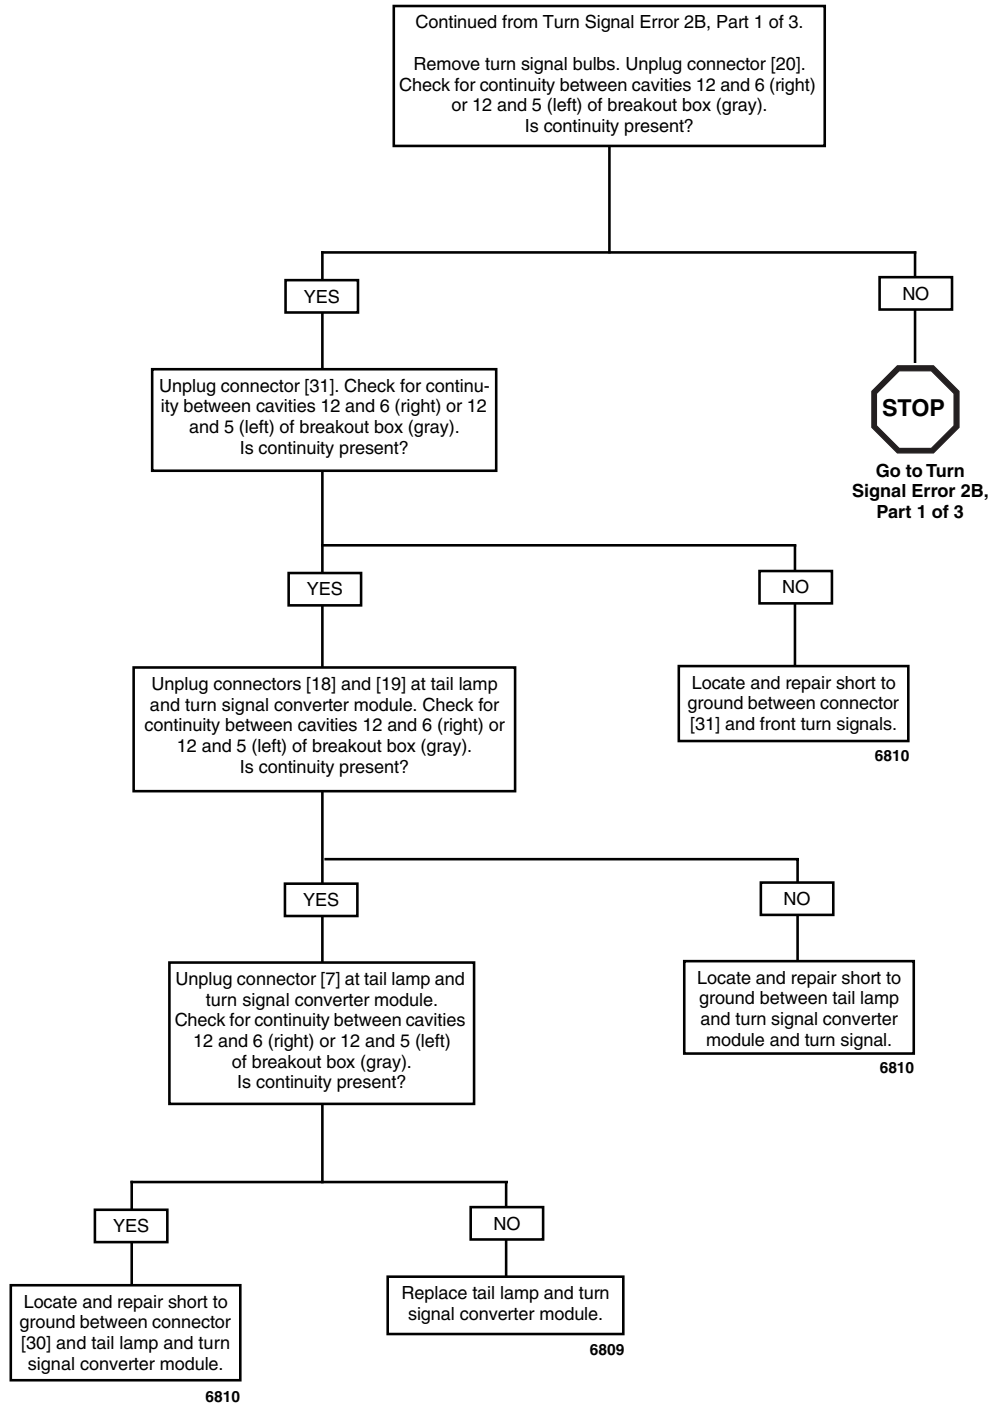
## Turn Signal Error 2B, Part 3 of 3

**WILL NOT FLASH, 4-WAY FLASHERS INOPERABLE: DTC: B1121, B1122, B1141**

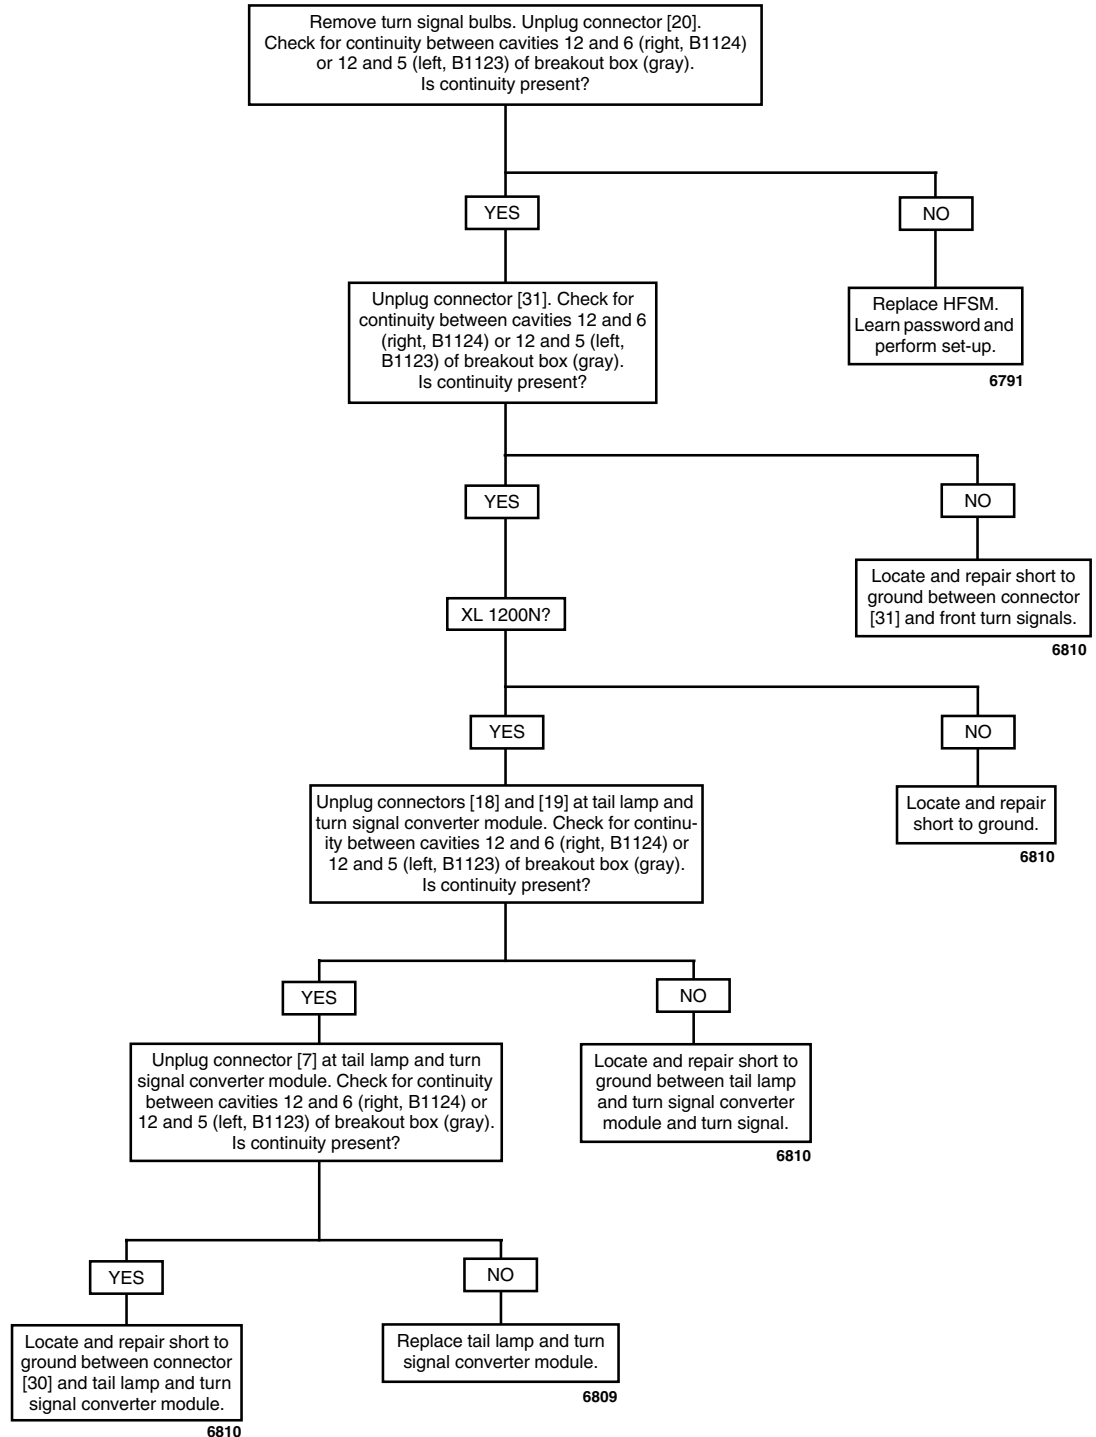
## Turn Signal Error 5A

DTC: B1123 LEFT TURN SIGNAL LAMP SHORT-TO-GROUND

DTC: B1124 RIGHT TURN SIGNAL LAMP SHORT-TO-GROUND

7. Rename "Turn Signal Error 3A (Part 3 of 4)" on page 3-44 to read, "Turn Signal Error 2C".
8. Rename "Turn Signal Error 3A (Part 4 of 4)" on page 3-45 to read, "Turn Signal Error 2D".
9. Replace page 3-47 (Turn Signal Error 5A) with "Turn Signal Error 5A" and its flow chart on page 9 of this document.
10. Replace page 3-48 (Turn Signal Error 6A) with "Turn Signal Error 6A" and its flow chart on page 10 of this document.
11. Replace Table 4-22 on page 4-69 with the table below:
