# SERVICE BULLETIN

M-1208B

Safety Recall Code 0131

## 2006-2007 XL EXHAUST SHIELD RECALL

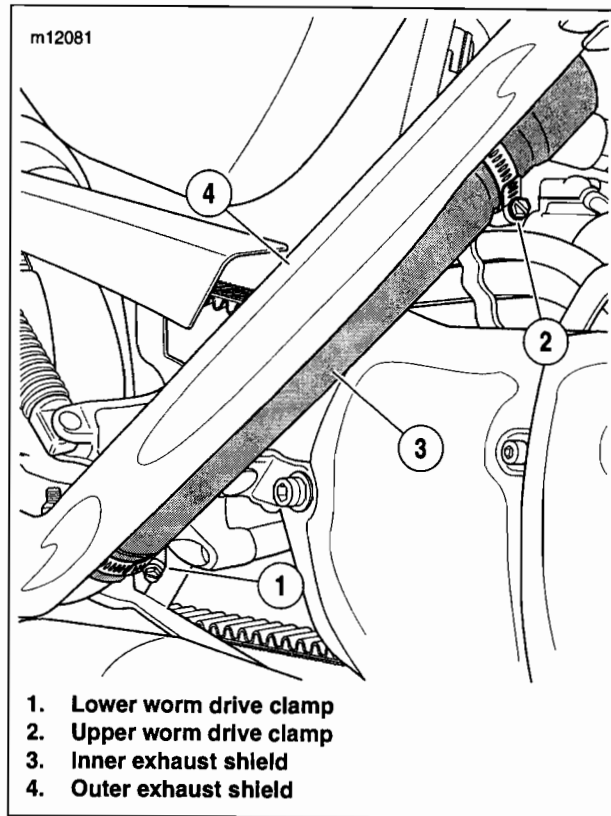
Figure 1. Inner Exhaust Shield Installation on Rear Exhaust Pipe

See Figure 1. If the vehicle is equipped with an original rear exhaust pipe (header) which does not have the inner exhaust shield installed, proceed to the installation instructions.

1. See Figure 1. Loosen the lower worm drive clamp (1) on the rear exhaust pipe.
2. Loosen the upper worm drive clamp (2).
  - a. See Figure 2. On 2006 model vehicles, loosen the upper worm drive clamp. Rotate the clamp (1) to accommodate the installation of the inner exhaust shield as shown.
  - b. On 2007 model vehicles, completely unfasten the upper worm drive clamp until the clamp opens.
3. See Figure 1. Slide the bottom portion of the **new** inner exhaust shield (3) against the exhaust pipe and into the lower clamp. The clamp should rest on the indented portion of the inner exhaust shield.

4. Tighten lower clamp securely.
5. Place the upper portion of the inner exhaust shield against the exhaust pipe.
6. Install the upper worm drive clamp(s).
  - c. See Figure 2. On 2006 model vehicles, install a **new** worm drive clamp (Part No. 9955) on the indented portion of the inner exhaust shield. Tighten both upper clamps securely.
  - d. See Figure 1. On 2007 model vehicles, install the upper clamp over the indented portion of the inner exhaust shield. Tighten clamp securely.
