SERVICE BULLETIN

M-1217

2005-07 POLICE MODEL ABS BRAKE LINE RECALL

08V-090

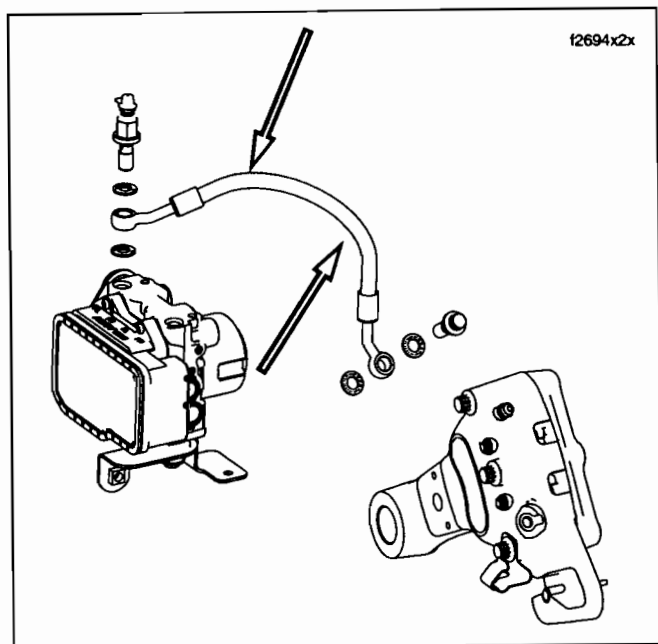
Figure 2. Brake Line 40610-05 to Saddlebag Cut Out and Adjacent Hoses

5. Take appropriate action based on both visual observation and feel of any wear marks.

1	No marks	Release until recall service performed
2	Slight cosmetic mark	
3	Slight mark, slight feel	Ground until recall service performed
4	Heavy mark, noticeable feel	
5	Leak
