# SERVICE BULLETIN

M-1223

July 29, 2008

## 2002-2008 TOURING MODELS STEERING HEAD BEARING TENSION CHANGE

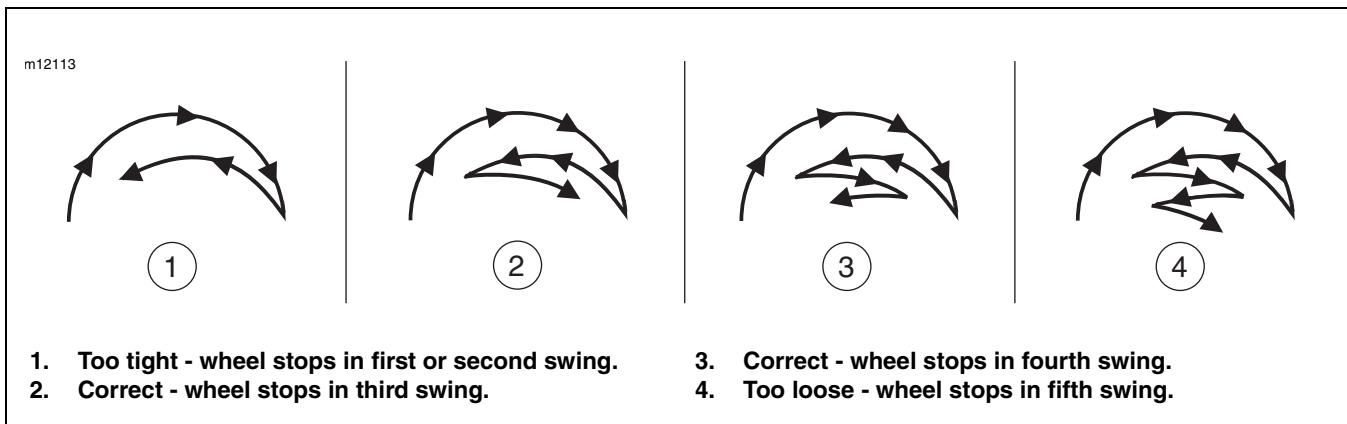
Figure 1. Check Steering Head Bearing Swing-By

Beginning in model year 2008 production, the allowable amount of swings while checking steering head bearing preload was increased to three to four swings. This change was included in the 2008 Touring service manual, and is applicable back through the 2002 model year.

*A steering head that is too tight can interfere with the vehicle's ability to absorb a weave. A steering head that is too loose can interfere with the vehicle's ability to absorb a wobble.*

See Figure 1. Perform the required procedure when needed, according to instructions in the 2008 and later Touring models service manual and verify swing-by falls into specified levels, as shown.
