SERVICE BULLETIN

BIG TWIN STARTER FASTENERS

M-1231

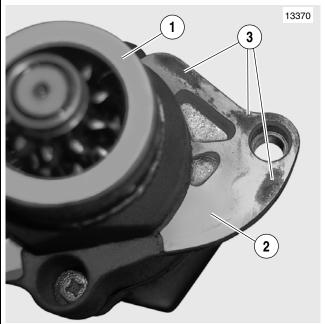
Figure 1. Fretting

It has been determined that some 2006 Dyna and 2007 Touring, Softail and Dyna model starter fasteners may lose clamp load. This can cause the starter to loosen and lead to poor ground contact which can result in poor starting as well as possible damage to starter.

- See Figure 1. Inspect starter mounting surface (2) and matching area on inner primary for fretting and arcing (3) which is a pitting condition caused by insufficient ground.
- Clean fretting on starter and mating surface with a dry abrasive pad.

- Starter
- 2. Starter mounting surface
- Fretting and arcing

For the 2008 model year, the starter fastener torque was increased to 25-27 ft-lbs (33.9-36.6 Nm). On the Softail and Dyna models, the increase in fastener torque will remedy the condition. On Touring models, the increase in fastener torque and replacement of the exhaust bracket will remedy the condition.

- Inspect starter pinion gear. Replace pinion gear if damaged (cracked or missing teeth). Rounding of pinion gear teeth is considered normal. If pinion gear needs to be replaced, inspect ring gear on clutch. Replace clutch ring gear if damaged.
- On Touring models, replace 65988-07 exhaust bracket with 65988-07A exhaust bracket. The 65988-07A bracket has an improved finish and minimizes clamp load loss.
- Install starter. Clean starter fastener threads. Apply LOC-TITE 243 (blue) to threads of starter fasteners. Tighten fasteners to 25-27 ft-lbs (33.9-36.6 Nm).
- Update the starter mounting bolt torque to 25-27 ft-lbs (33.9-36.6 Nm) in the:
 - 2006 Dyna service manuals
 - 2007 through 2009 Dyna, Softail and Touring service manuals
