SERVICE BULLETIN

M-1243

March 18, 2009

2009 TOURING MODEL JIFFY STAND BRACKET LEAN ANGLES

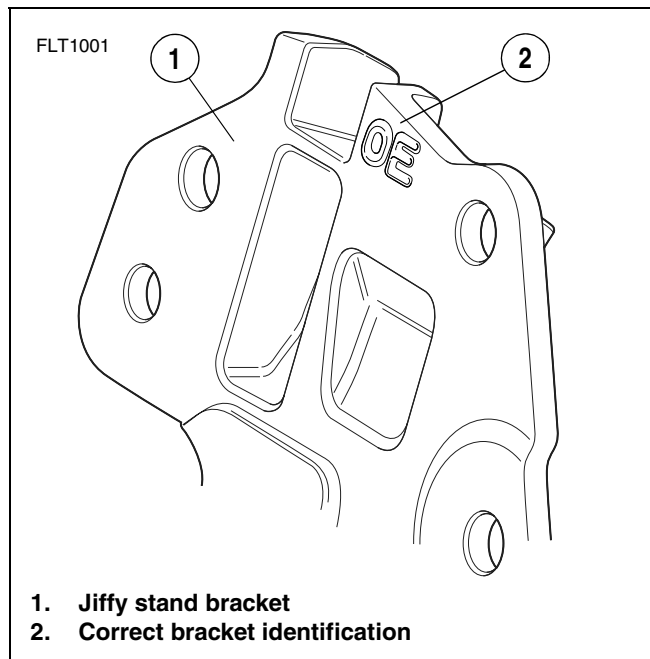
A small number of 2009 touring model motorcycles were built with a jiffy stand bracket which allows the vehicle to lean over more when resting on the stand. If an owner of an affected vehicle wants to change to a bracket which allows a more upright resting position, the repair is covered under warranty.

Figure 1. OE Identification Marking on Bracket

1. See Figure 1. Inspect for the OE embossing (can be felt by reaching behind on back of jiffy stand bracket).
2. Replace with a 50096-09 bracket ONLY if the OE embossment cannot be seen or felt, and the customer requests replacement.
3. If the bracket is to be replaced, perform the required procedure according to instructions in the appropriate model service manual.
