SERVICE BULLETIN

M1359 2019-02-22

M1359: 2014 - 2016 TOURING - HYDRAULIC CLUTCH LINE REPLACEMENT

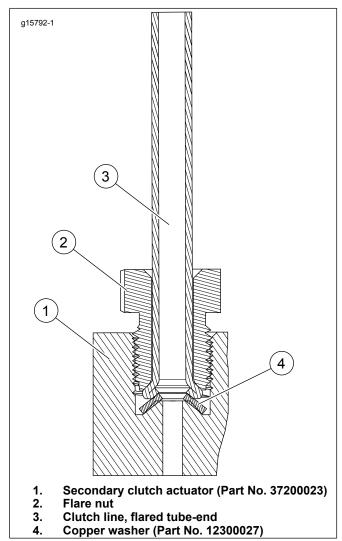
Figure 2. Copper Washer Orientation

Copper washer can only be installed in secondary clutch actuator once. It is very difficult to remove from the cavity after it has been in service. A clutch line may be installed multiple times on an actuator with a copper washer installed as long as a seal can be achieved.

- See Figure 2. Hold secondary clutch actuator upright. Install copper washer (Part No. 12300027) in the actuator cavity. Allow copper washer to self-center.
- 3. Tighten the clutch line flare nut to initial torque.

Torque: 10.9–16.3 N·m (96–144 in-lbs) Clutch line flare nut - initial torque
