SERVICE BULLETIN

M-1401 April 13, 2015

PRODUCT PROGRAM 0919: 2015 STREET MODELS RIGHT SIDE RIDER FOOT CONTROL MOUNTING SCREWS

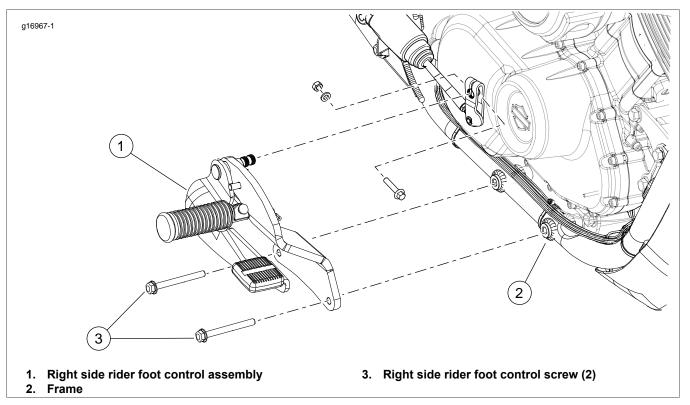
Figure 1. Right Side Rider Foot Control Assembly

Our records indicate you are the owner of a 2015 XG model motorcycle. Harley-Davidson has recently discovered that the rider right foot control mounting bolts on some model year 2015 XG model motorcycles may have been assembled with an improper torque.

- 2. See Figure 1. Loosen both right side rider foot control mounting screws (3).
- 3. Retighten screws to 22.0-29.0 Nm (17-21 ft-lbs).
