# SERVICE BULLETIN

M1438 2017-01-25

# M1438: NEUTRAL SWITCH INVENTORY REMOVAL

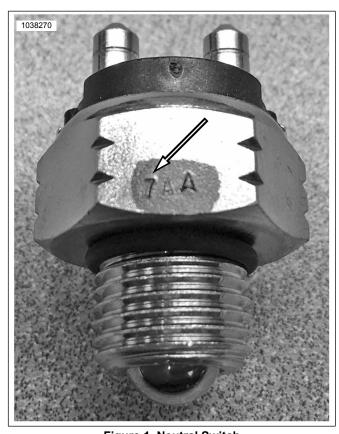
Figure 1. Neutral Switch

Bulletin M1438 notifies that Harley-Davidson has determined that a variance in assembly tolerances may affect the functional performance of certain Neutral Switches (Part No. 33926-06B) causing no or inconsistent neutral light illumination while the transmission is in neutral.

Neutral Switch (Part No.33926-06B) with the assembly code marking that begins with the number "6" or lower.

- 2. See Figure 1. Inspect the assembly code.
  - Switches with the 3-digit assembly code that begin with the number "6" or lower should be removed from inventory.
  - b. Switches with the 3-digit assembly code that begin with a "7" or greater can remain in inventory and be used for repair.
- 3. File a warranty claim for switches that failed the inspection. Use the appropriate table in Credit Procedure.
- Order replacement switches (Part No. 33926-06B) using the standard part ordering process for your market. Suspect inventory has been removed from HDMC warehouses.

In an effort to reduce to the potential of repeat issues by the installation of a suspect replacement neutral switch, Harley-Davidson is requesting that dealers file a Defective Stock (DFS) claim on any existing neutral switches with the identification numbers described in Required Dealer Action, and remove the switches from inventory.
