# SERVICE BULLETIN

M1470 2020-05-20

## M1470: SAFETY RECALL 0171: 2008 - 2011 ABS MODELS - NEW HARLEY-DAVIDSON PLATINUM LABEL DOT 4 BRAKE FLUID

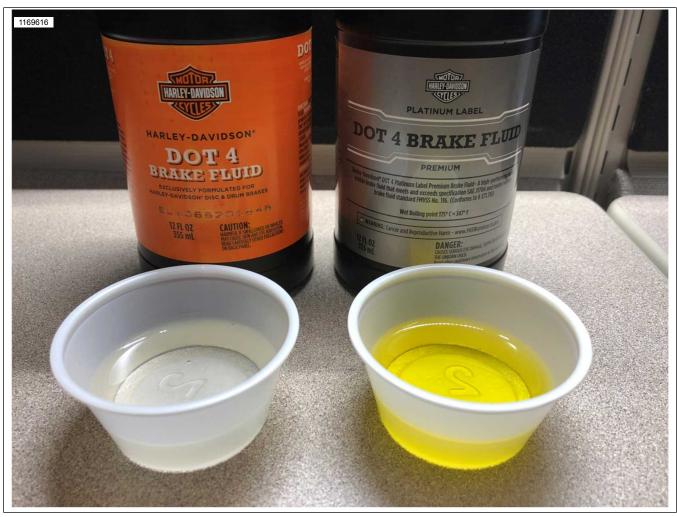
Figure 1. Dot 4 Brake Fluids

See Figure 1. The difference in Platinum Label DOT 4 Brake Fluid chemistry will result in a noticeable color difference

between the two fluids. The current DOT 4 BRAKE FLUID (41800219) is clear in color. The **new** fluid has a yellow tint to the fluid. Some may describe it as a yellow/green tint as well. These fluids are completely compatible and topping off one with the other, or slight mixing during the flushing process is not a problem.
