SERVICE BULLETIN

M1482 2019-04-12

M1482: RECALL 0173 - SECONDARY ACTUATOR ASSEMBLY REPLACEMENT

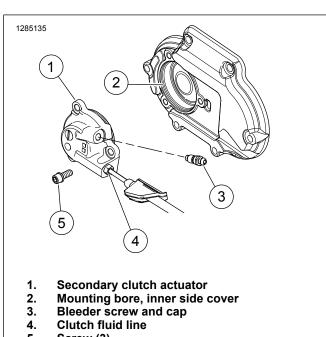
Figure 1. Secondary Clutch Actuator

- A small amount of transmission lubricant may drain when secondary clutch actuator is removed.
- · Do not disconnect clutch fluid line (4).
- See Figure 1. Remove secondary clutch actuator (1) from inner side cover mounting bore (2).
 - Remove screws (5) and secondary clutch actuator.
- See Figure 2. Place clean lint free shop towel over transmission inner side cover at secondary actuator bore.

- 2. See Figure 1. Install secondary clutch actuator (1).
 - Lubricate mounting bore (2) in the inner side cover with a film of transmission fluid.
 - b. Install secondary clutch actuator (1) and screws (5).
 - See Figure 6. Draw screws down evenly to prevent binding and possible breakage of mounting ears. Tighten in sequence as shown.

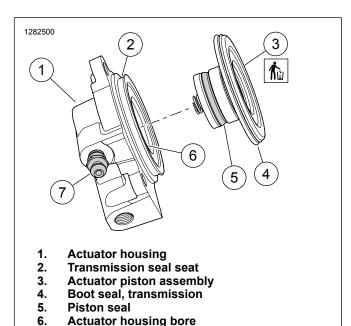
Figure 3. Secondary Actuator Assembly

To avoid scratching the transmission seal seat (2), do not use any tools to remove the transmission seal boot (4) from actuator housing (1).

- 2. See Figure 3. Clean actuator.
 - a. Use the provided wipe, thoroughly clean the actuator bore and transmission seal seat area (2, 6).
- Inspect actuator bore for damage.
 - If damage is found, replace actuator assembly.

- 1. See Figure 3. Remove the actuator piston assembly (3).
 - See Figure 4. Pinch the actuator transmission seal boot (4).
 - See Figure 3. Remove the transmission seal boot b. from the transmission seal seat (2).
 - Remove piston assembly from actuator housing (1).
- Hold old actuator piston assembly per Return Parts.

- See Figure 3. Remove **new** actuator piston assembly (3) from packaging.
- 3. Inspect **new** actuator piston assembly for dirt or damage.
 - a. If dirty or damaged, do not use.
- 4. Install new actuator piston assembly.
 - a. Align **new** actuator piston assembly squarely to the actuator housing bore (6).
 - See Figure 5. Push down on center of piston until fully seated in bore.
 - c. See Figure 3. Install the transmission boot seal (4) around the transmission seal seat (2).
