SERVICE BULLETIN

M1509 2020-02-13

M1509: MILWAUKEE-EIGHT CYLINDER FLANGE NUT USAGE

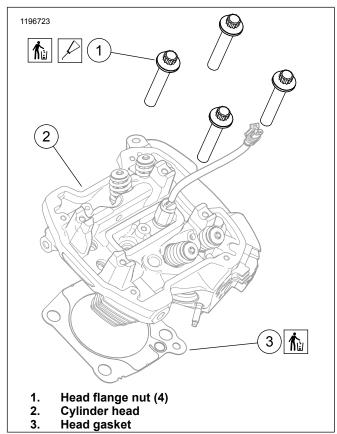
Figure 1. Cylinder Head

To Inform dealers of a service manual change. This change affects the flange nut attaching the cylinder/cylinder head assembly to the cylinder stud in all MKE-8 (Milwaukee-Eight®) engines. The flange nut is one-time use and is replaced after removing.

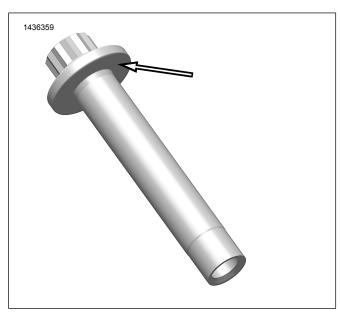
Figure 2. Flange Nut Lubrication Area

An additional change is the lubrication of the flange nut. Verify that only the bottom of the flange nut receives lubrication. Do not allow lubrication on the cylinder stud or on the internal threads of the flange nut.

- Do not install used flange nuts on MKE-8 vehicles when servicing, always replace with new OEM (Original Equipment Manufacturer) parts.
- See Figure 2. Only oil the bottom of the flange when installing, not the threads of the flange nut or cylinder studs.

The engine oil used on that particular engine should be used as the lubrication for the flange nut.
