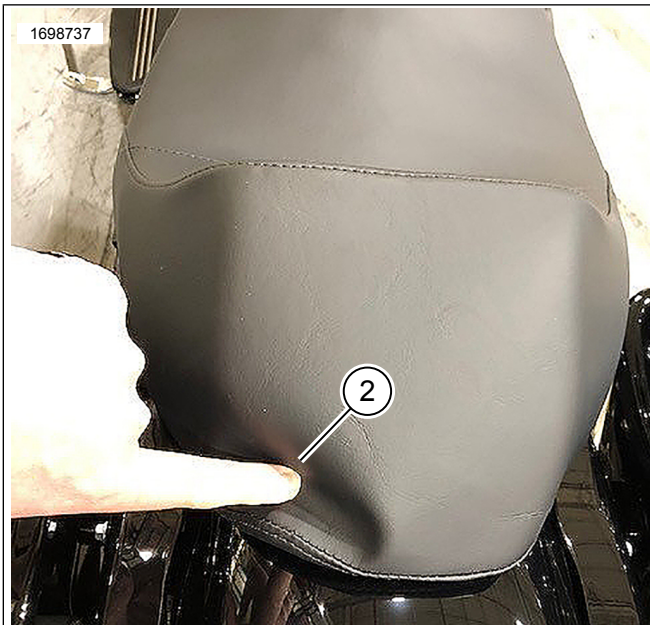
Figure 2. Suspect Area

2. Applied pressure

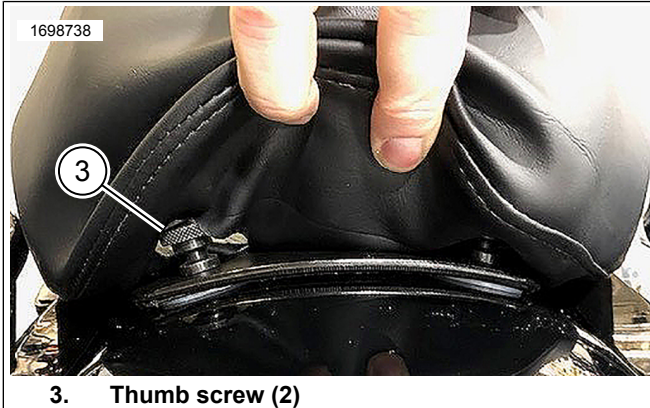
Figure 3. Root Cause

3. See Figure 3. Missing seat foam padding.

- a. **Root Cause:** During installation, the rear of the seat must be pulled over the two thumb screws (3). It happens to be that the foam padding in the rear corner folds back into the seat during the installation.
- b. **Repair:** The foam padding can be repositioned with one finger through the opening of the seat bottom.

3. Thumb screw (2)

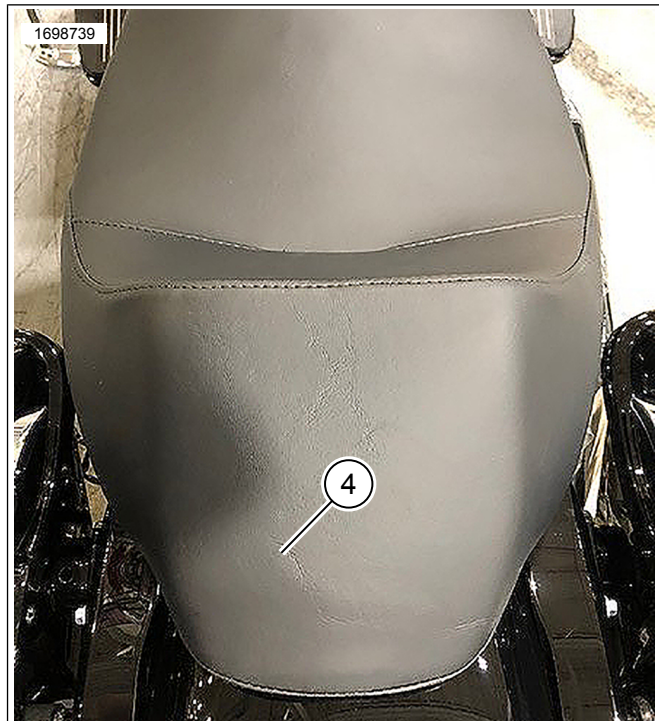
Figure 4. After Repair

4. See Figure 4. The same bike seat is shown after the foam padding has been properly seated (4). There is no visible sunken area.

4. Properly seated

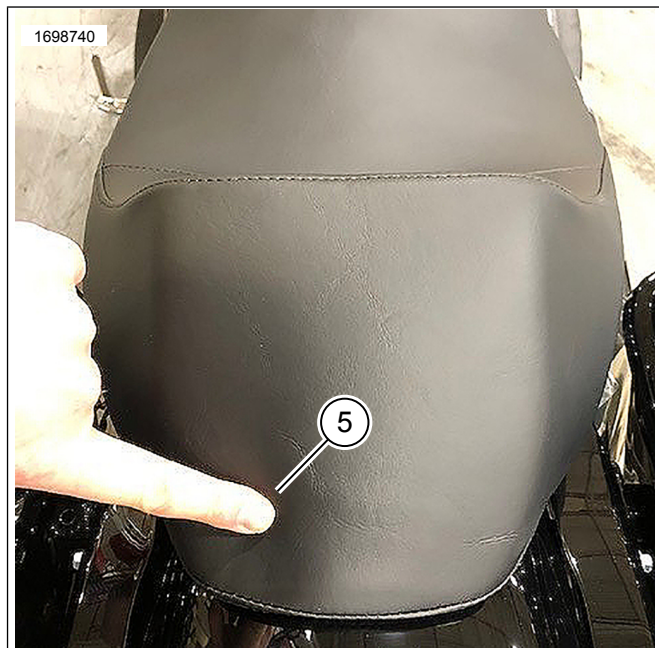
Figure 5. Proper Adjusted Padding

5. See Figure 5. A push test (5) on the rear of seat confirms that the foam padding has been properly adjusted.

5. Push test
