SERVICE BULLETIN

B-003

March 1995

VEHICLE IDENTIFICATION NUMBER (V.I.N.) UPDATE

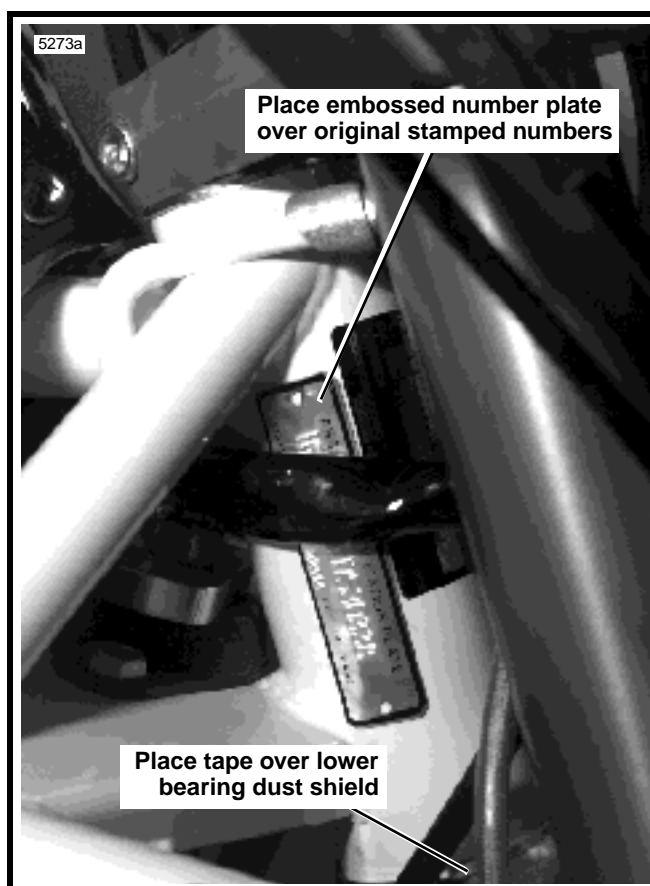
Figure 3. Preparing Steering Neck Tube

A letter dated March 6, 1995 was sent to all Buell dealers stating that a number of 1995 Buell S2-Thunderbolts may have incorrectly stamped V.I.N. numbers. The affected units will display an incorrect numeric character, 5, in the tenth position of the 17-digit V.I.N. code on the right side of the steering head.

1. See Figure 3. Place a strip of tape over lower bearing dust shield.
2. Remove backing from **new** peel-n-stick V.I.N. label. Apply label to steering neck tube allowing space for embossed number plate to cover old V.I.N. stamped into frame.
3. Remove backing from adhesive strip on embossed number plate. Hold number plate over original stamped number. Plate must cover original numbers completely.
4. Center punch two mounting holes for embossed plate.
