SAFETY RECALL CODE 0813 - SIDESTAND SWITCH

Buell Motorcycle Company has learned that certain 1996 through 1999 Buell motorcycles were built with a sidestand switch that could become inoperative. This condition could cause the engine to stall or quit when riding which could result in an accident. Accordingly, Buell Motorcycle Company is conducting a voluntary recall campaign to formally recall all potentially affected motorcycles.

This campaign involves all 1996 through 1999 S1 Lightning, S1 White Lightning, X1 Lightning, M2 Cyclone, S3 Thunderbolt and S3T Thunderbolt model Buell motorcycles manufactured between January 20, 1995 and April 21, 1999.

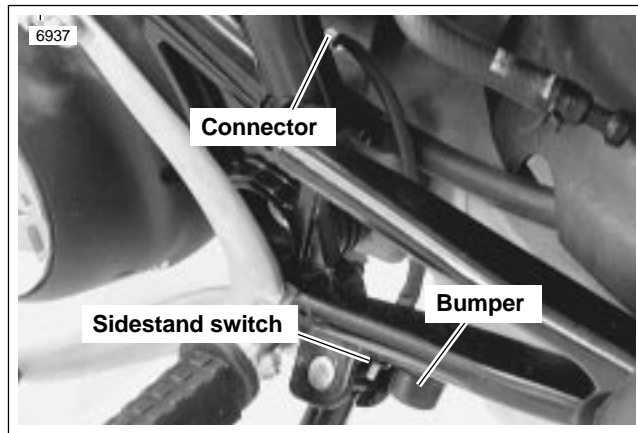
Figure 1. Original Sidestand Switch and Bumper

See Figures 1, 2 and 3. The current sidestand switch can be differentiated from the replacement one by noting the differences in the plunger. The current plunger is made of white plastic and has a flat tip. The plunger of the replacement switch is made of metal and has a round tip.

1. Disconnect negative battery cable.
2. See Figure 1. Unplug sidestand switch wiring from connector.
3. Remove switch from vehicle frame and discard.

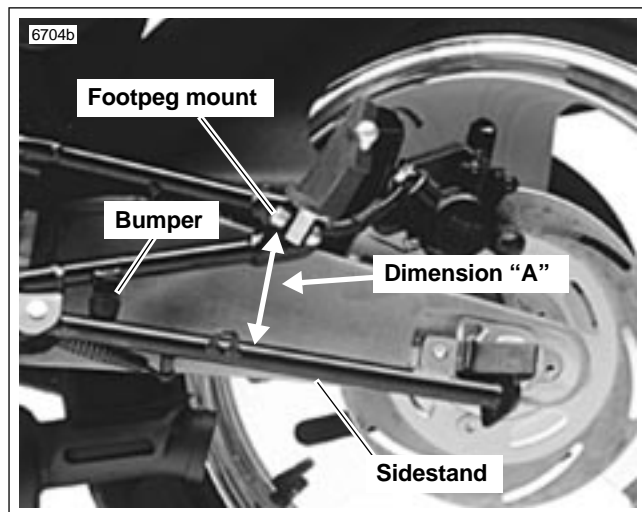
Figure 4. Dimension "A" Measurement

- See Figures 5 and 6. Dimension "B" is determined by measuring the distance perpendicular to the left outside surface of the swingarm to the sidestand dragger mount.
- See Figure 4. Dimension "A" is determined by measuring the distance perpendicular to the top side of the sidestand to the lower edge of the passenger footpeg front mount tab.

1. Remove and discard original sidestand bumper and spacer washers.
2. See Figures 4 and 5. Establish correct sidestand retraction angle by using either the new cylindrical bumper or the new conical bumper in conjunction with up to three spacer washers. The sidestand retraction angle is defined by Dimension "B". Dimension "B" must be within 0.500-0.625 in. (13-16 mm). Keeping Dimension "B" within specifications listed, measure Dimension "A". Dimension "A" must not exceed 3.125 in. (79 mm).
3. Using the bumper and washer combination determined in Step 2, place a small amount of LOCTITE THREAD-LOCKER 243 (blue) on the bumper threads and install it into the frame.
4. Hand tighten securely.

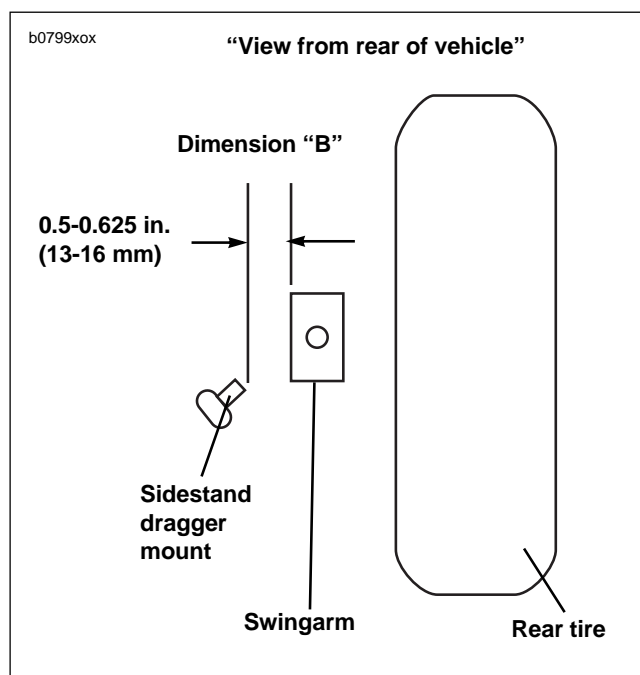
Figure 5. Dimension "B" Measurement

See Figures 3 and 5. The objective of this procedure is to obtain both a **minimum** sidestand switch plunger depression of 0.125 in. (3 mm) **and** a **minimum** sidestand/swingarm clearance (Dimension "B") of 0.5 in. (13 mm) when the sidestand is in the retracted position.
