2006 Throttle Body and Throttle Position Sensor Production Change

Purpose

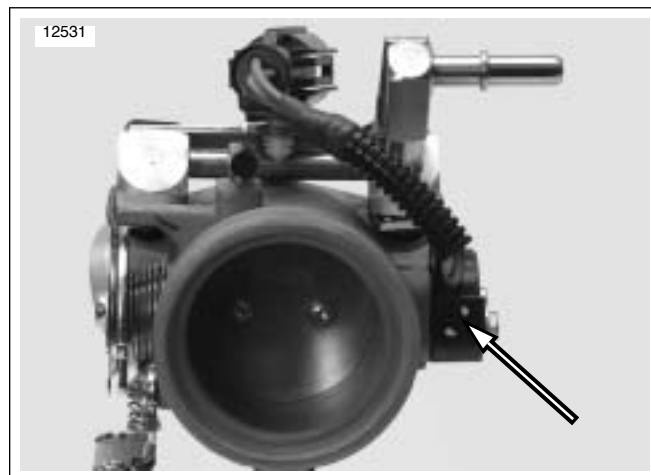
Throttle position sensors are not interchangeable before and after production change. There are two methods to identify the new style TPS. The new TPS can be identified by either one or two orange dots on the top of the sensor. see [Figure 1](#). and supplier Julian date code [Table 1](#).

Figure 1. Orange Dots Indicating New Throttle Position Sensor

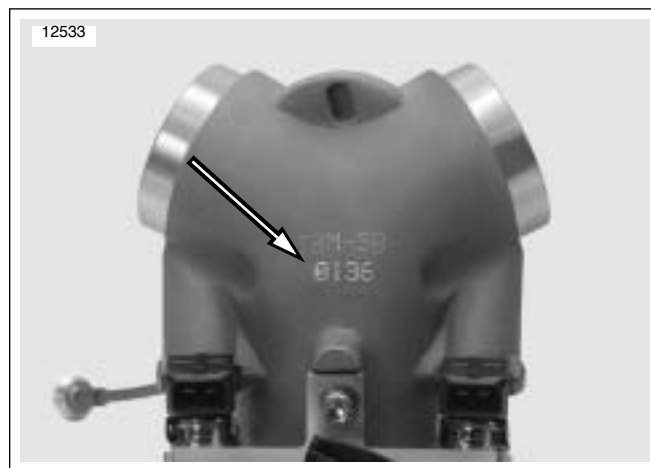
Figure 2. Julian Date Code

See [Figure 2](#). The supplier Julian date code is not the Buell implementation date of new style throttle body and throttle position sensor. Refer to [Table 1](#). for correct information on implementation dates. **All new style throttle body assemblies are marked with a four character supplier Julian date code beginning with 0136 and higher.**

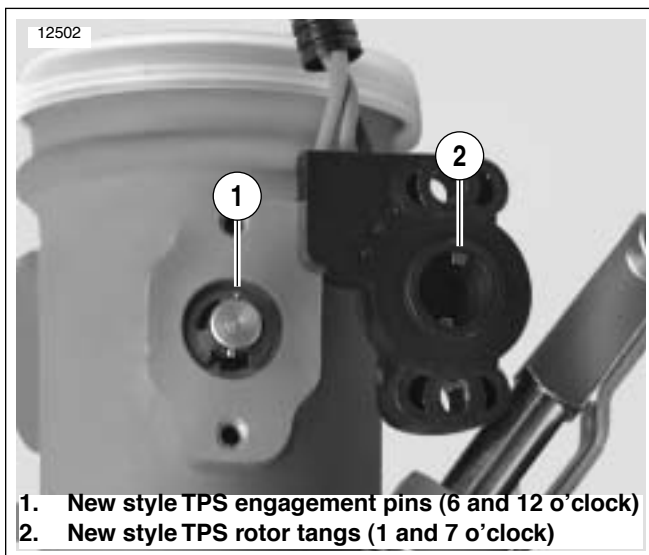
Figure 3. New Style Throttle Body and Throttle Position Sensor

See Figure 3. The new throttle shaft TPS engagement pins are oriented at the 6 and 12 o'clock positions. The new TPS rotor tangs are at the 1 and 7 o'clock positions.

Ensure that proper orientation is followed when replacing TPS. See Figure 3. and Figure 4.

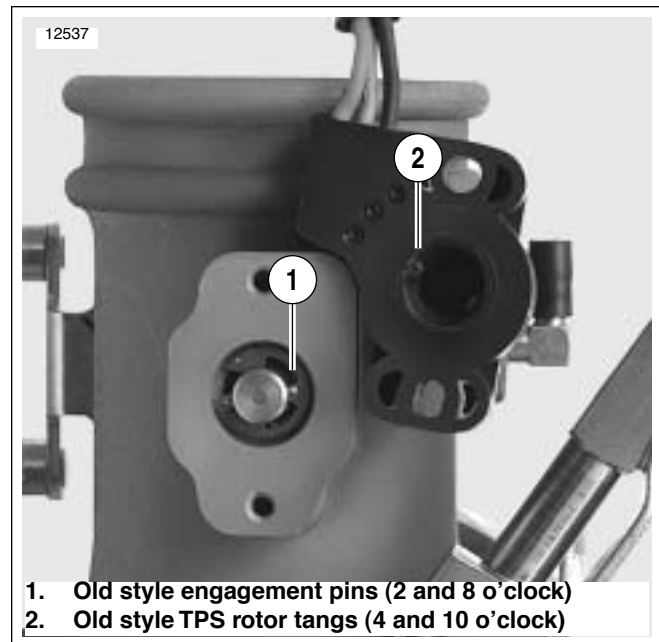
Figure 4. Old Style Throttle Body and Throttle Position Sensor

See Figure 4. The old throttle shaft TPS engagement pins are oriented at the 2 and 8 o'clock positions. The old TPS rotor tangs are at the 4 and 10 o'clock positions when viewed disassembled.
