ML-271

The Service Department, in an effort to provide an informational recap of both past and present repair procedures, has assembled the attached pages of Technical Tips.

Service Letter ML-271

TECHNICAL TIPS

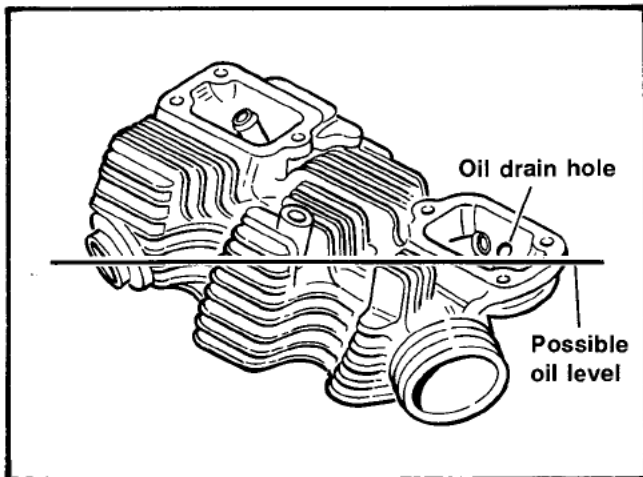
Figure 1. Oil Drain Hole

6. Has your 1984 and early 1985 XL customer complained of a valve train clatter, power loss and backfiring through exhaust system after a short trip?

This could be a sign that an exhaust valve is beginning to stick. See Figure 1. If this is the case hold the head at the approximate angle it sits on the cylinder. You may observe that the oil drain hole is almost even with the top of the valve guide. This drain hole should be lowered to keep oil level well below the top of the guide. Lower hole with grinding tool.

Do not drill; you could break into exhaust port.

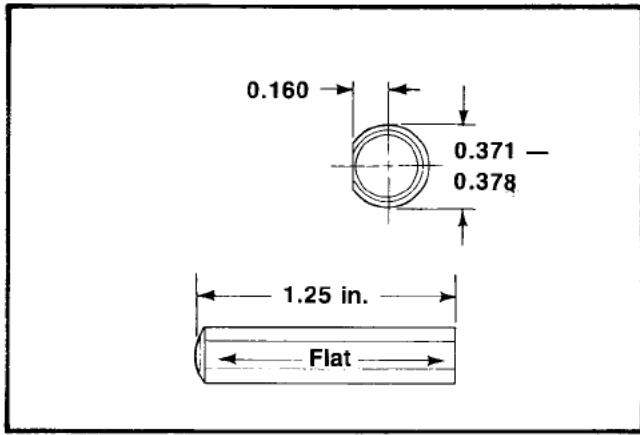
Figure 2. Clutch Pushrod

9. Does your customer with a late 1984 vehicle have chronic oil leaks at the rear of the primary case?

This leak may seem to be coming from the O.D. or I.D. of the inner primary bearing or on 4-speed vehicles, from the starter motor housing or around the head of the starter drive actuator arm mounting screw on top of the primary housing.

The inner primary vents through the mainshaft and out the transmission vent hole or hose by means of a flat which is ground the length of the clutch pushrods. A small percentage of late 1984 vehicles did not have a flat on the pushrod closest to the adjuster.

Remove the clutch cover. Release any tension on the adjuster screw. Remove the snap ring and adjuster mounting block and remove the clutch pushrod.

See Figure 2. If there is no flat on the clutch pushrod, grind one the length of the pushrod.

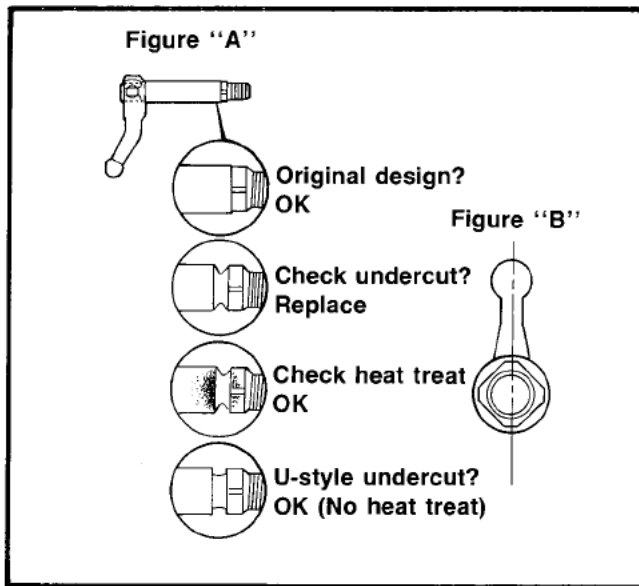
Figure 3. Four Speed Shifter Shaft

11. Has your customer experienced chronic false neutrals with his 4-speed? Have you ridden his 4-speed and confirmed this?

See Figure 3. Inspect shifter shaft in transmission top cover. Part No. 34652-80. Check for twist or improper indexing of shifter shaft finger ball to cam end.

Using a straight-edge, as shown in Figure "B", the ball end should be split in half. If it is not split in half the shaft is twisted or improperly indexed. Replace shifter shaft.

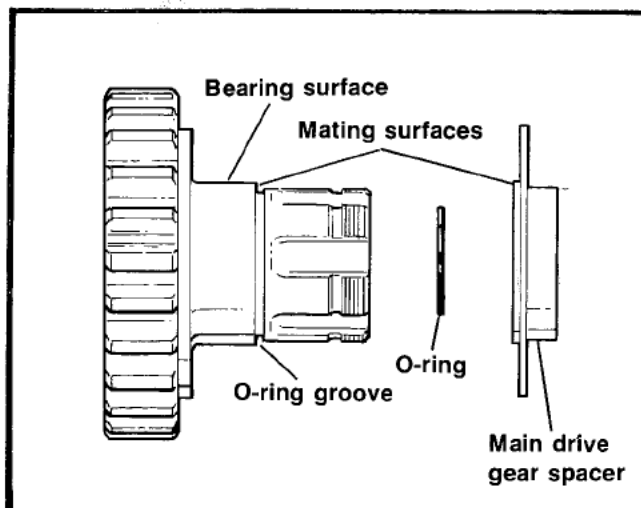
Figure 4. Main Drive Gear and Spacer

Oil passing between the main drive gear spacer and the main drive gear (spline leaks).

- (1) Remove inner primary. See DRIVE section in Service Manual.
- (2) Drain lubricant from transmission.
- (3) Remove main drive gear spacer and seal.
- (4) Clean main drive gear to spacer mating surfaces so they are oil free.
- (5) The main drive gear spacer you removed should be replaced with the appropriate new spacer:
Rear Belt Drive – P.N. 35070-84
Rear Chain Drive – P.N. 35079-84
- (6) See Figure 4. Apply a light coat of machinist's blue to the main drive gear spacer's mating surface.
- (7) Install spacer on the main drive gear and rotate spacer to establish the location of the contact patch. Remove spacer and verify this contact area. There should be 360° of even contact. If a good

mating surface cannot be established try another spacer, because the chamfer may be too large. If you have any questions contact the Technical Service Department.

Install O-ring part no. 1114. **Do not use a substitute.** Take care to protect the O-ring from the splined threads of the main drive gear. Use masking tape on the splines. Install the O-ring in groove directly against shoulder. Coat O-ring with a light grease such as vaseline.

- (9) Install seal and new main drive gear spacer.
- (10) Follow assembly instructions as found in Service Manual. Do not use an impact wrench to install the main drive gear sprocket nut because proper torque is essential. This torque is 80-90-ft-lbs. Apply a small amount of Loctite #242 to the threads of the main drive gear sprocket nut. Do not apply any Loctite to main drive gear threads.
- (11) Complete vehicle assembly and refill transmission and primary with appropriate lubricants, as required.

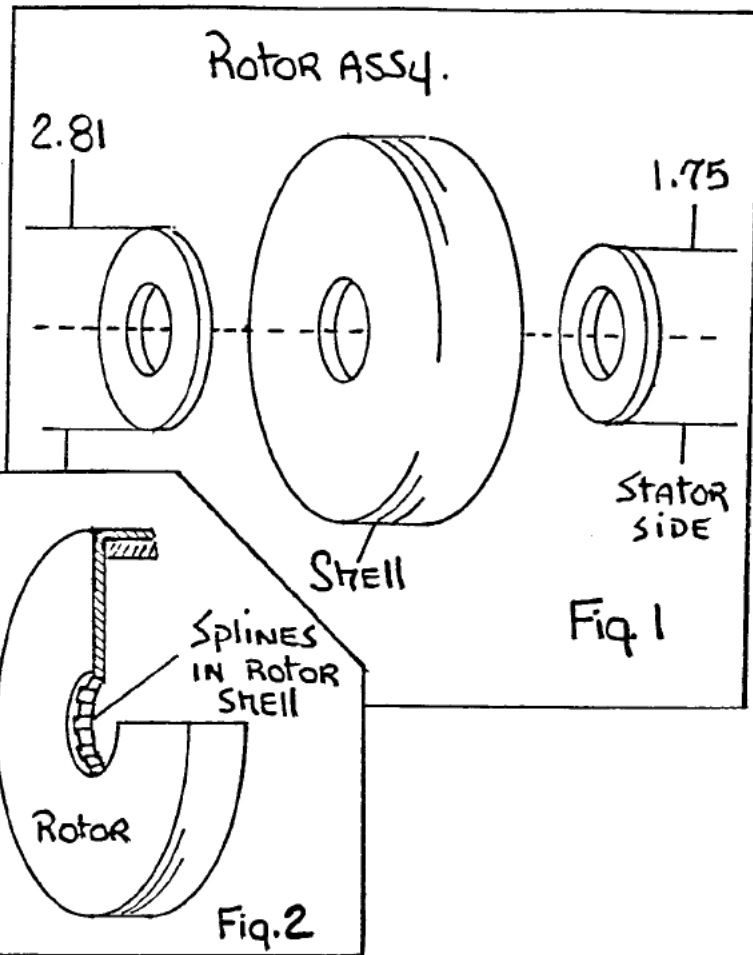
Have you noticed a change in the alternator rotor assembly on 1340 engines?

The brazed splined insert was removed, starting Crankcase #1585-314-067. Flatwashers were then used in place of the brazed insert. Since splines were removed, proper torque is essential in maintaining adequate clamp load to the rotor assembly. Use #242 Loctite on the threads of the compensator nut. See Figure 1 for proper assembly.

In Jan. of 1986, the rotor shell will be machined with splines. The same flat washers will still be utilized. See Figure 2. This should be considered a product improvement as both splined and nonsplined rotors perform satisfactorily.

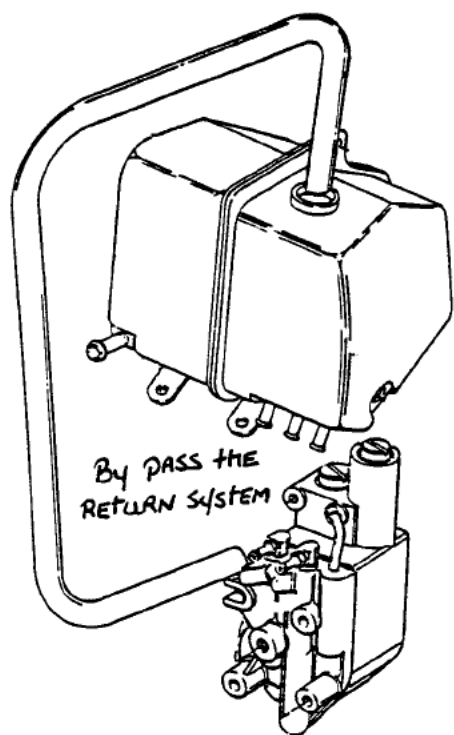
Diagnostic's 2

Return system vs motor: Remove
the return hose at the oil pump
return fitting and plug the hose,
so oil doesn't run everywhere.
Select a length of oil hose long
enough to reach the oil tank
filler neck when connected to the
oil pumps return fitting.

Note: Before connecting the test
hose note the number of
threads exposed on the return
fitting to return elbow
connection. Remove the fit-
ting and elbow and inspect
how far the fitting is
screwed into the elbow. The
fitting may be restricting
the return oil flow. See
fig. (1). Modify fitting as
required and reinstall.

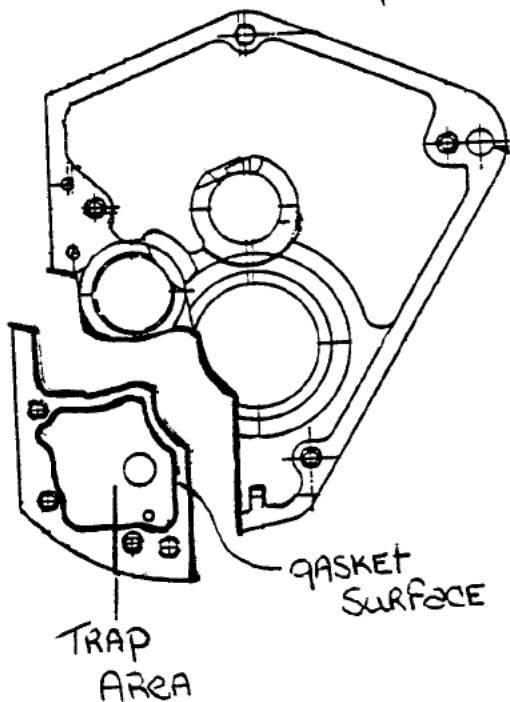
Fig. 2 Cam Compartment

Examine the following

- 1.) Oil pump return pockets for damage, grooves, a sheared drive gear key.
- 2.) A damaged breather gear or pocket or out of time. Don't just look at it, pull it out.
- 3.) A damaged gasket surface between the trap area and the cam compartment. See figure (2).
- 4.) A cracked or porous cam cover.
- 5.) A plugged evacuator hole in the trap compartment.
- 6.) A plugged return passage to the return gears.

If you haven't found it by now, don't put it back together, call us first. Maybe we have some new revelation that might solve the problem.
