TECH TIPS # 21  
9/10/90

IMPORTANT INFO: 1991 Sportster Voltage Regulator Wire Rerouting.

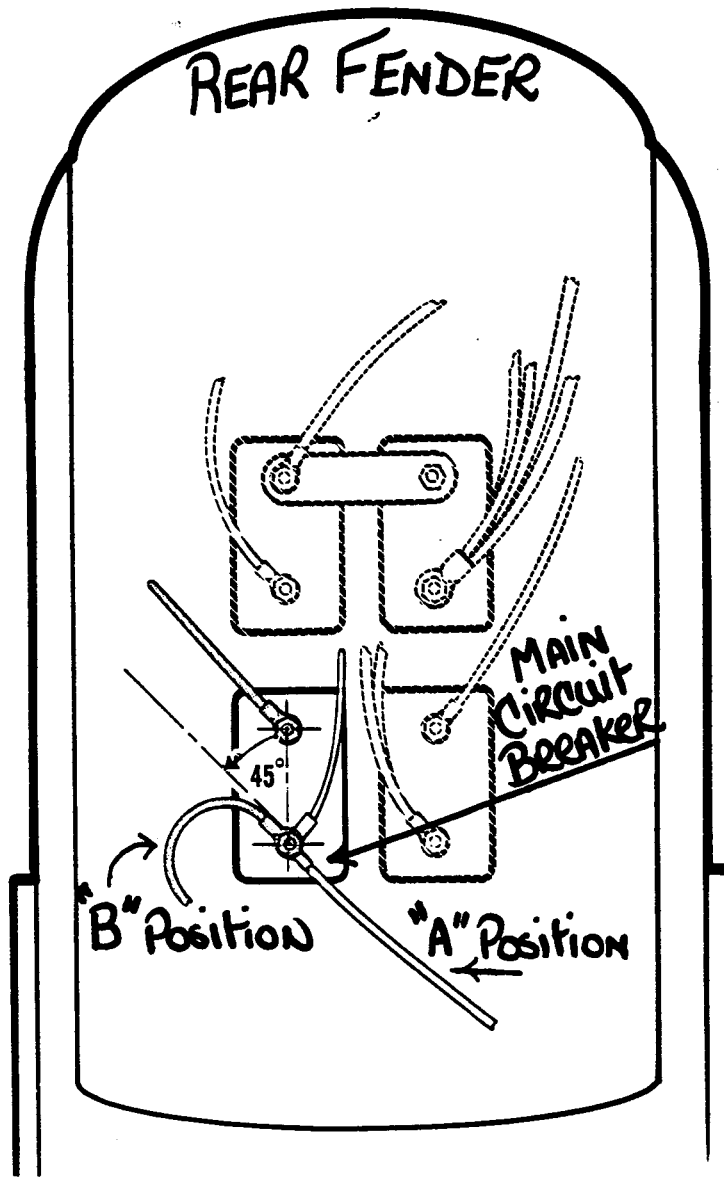
1991 XL assembly variations could cause contact between the black voltage regulator wire and the oil tank or transmission vent hose. The voltage regulator wire is connected to the silver stud on the main circuit breaker. (See the drawing below) To correct this condition, please rotate the regulator wire from "A" position to the "B" position. Should this not be done the connector may fail leading to regulator damage and an inability to maintain the batteries state of charge. Thank you!
