TECH TIPS # 28

FEBRUARY 1992

ALL MODELS

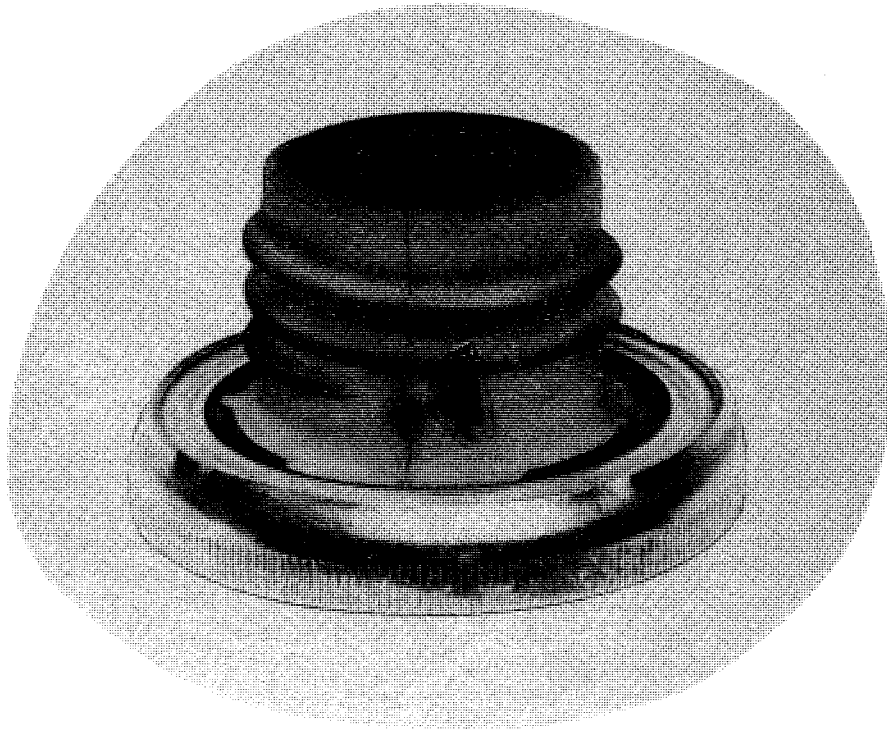
As we mentioned in Tech Tips #23, a change was made to fuel cap gaskets last year to help eliminate Softail fuel tank staining. Production and field use of that gasket (61109-85C) has helped a lot. Here's another "anti-stain" tip. A number of left fuel caps (61103-83A) used on 1990 and early 1991 Softails may be contributing to the condition. To identify a prospect, unscrew the left cap and turn it upside down. Check the die number stamped at the bottom of the middle cavity of the cap. It will be either a 1 or 2. If it's a 2, examine the cap further. Check the area where the left handed thread just starts near the top of the plastic sleeve, in the vicinity of the parting line from the die. If you notice a small depression or sunken area, replacing the cap could prevent a stain from occurring.
