TECHNICAL

TIPS

January 1996
TT#44

TECH TIPS #44

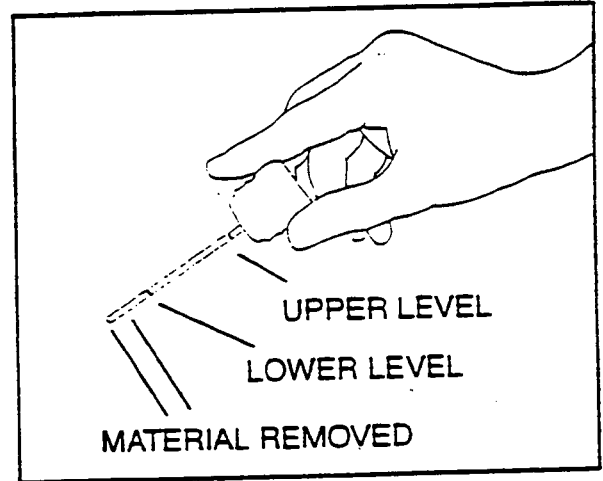
DIPSTICK COMMONIZATION - FX/XL

An upcoming production change will be the commonization of oil tank dipsticks between Sportster and Softail models.

Shortening the dipstick will allow it to fit in both model's oil tanks. The location of the lower level mark is the same. The upper fill mark, which Softails previously didn't have, is applicable to all dels.

The new part number, 62634-84A, retrofits to Softail models - 1984 and later and Sportster models - 1982 and later.

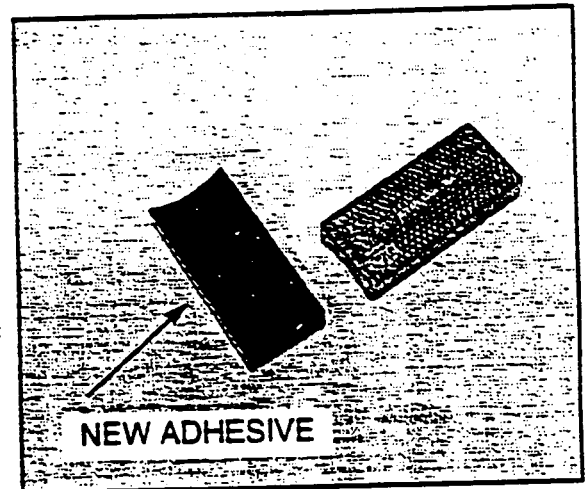
NEW REFLECTORS

The adhesive material used to retain the front frame reflectors has been changed on all models. The improved adhesive will change the color of the adhesive material from white to black. This will also eliminate the cable straps which technicians had to remove during predelivery and set-up.

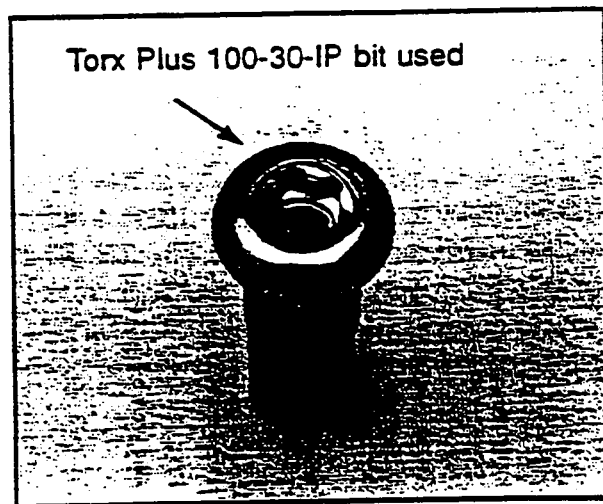
SPOKED WHEEL CHANGE

An important 1996 model year running change will be occurring soon on laced wheel assemblies. The spoke nipple is a new style which requires a special Torx Plus driver for installation. The Torx Plus driver, 100-30-IP, should be used to start or remove stubborn spoke nipples. A conventional spoke wrench will still be used to do final wheel truing. We are going to make the tool available through Kent-Moore as you can't purchase this from a vendor like Snap-On or Mac etc. The part number will be HD-42135.

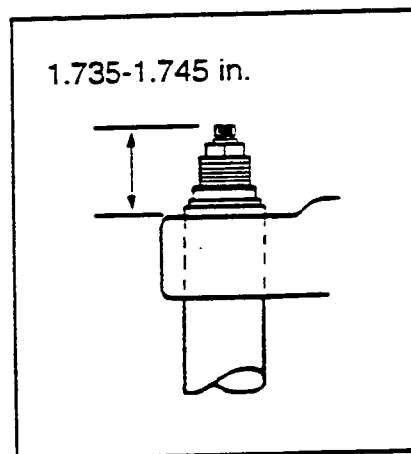
XL SPORT FORK HEIGHT

The 1996 Predelivery & Set-up Manual indicates the fork tube height for XL Sport model is 0.735-0.745 in., it should be 1.735-1.745 in. (44.1-44.3mm) with the adjuster knob fully bottomed. Please make note of this.

The 1995/96 XL Service Manual lists the correct height.

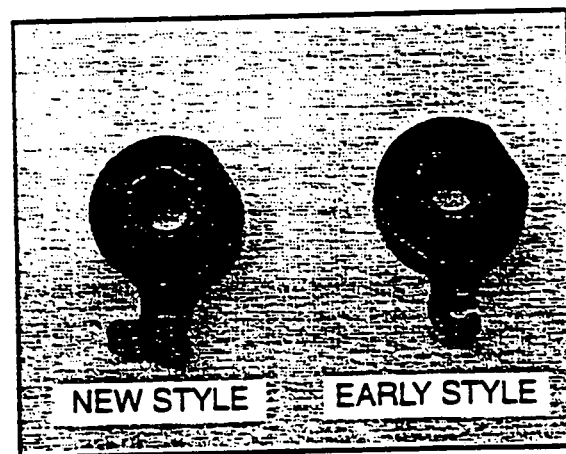
CLUTCH RELEASE RAMP CHANGE

Beginning with vehicles built in early January, the outer clutch release ramp has been changed. The new ramp, part number 25409-94A, has the coupler on the inside of the ramp. The clutch adjustment procedure and lever freeplay remain the same. The change was made to prevent any possible contact between the coupler and primary cover.

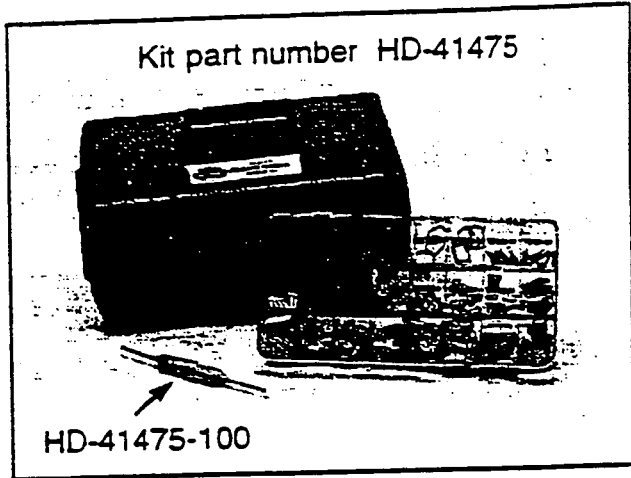
DEUTSCH TERMINAL KIT

An electrical terminal kit is now available through Kent-Moore Tool. The kit contains a selection of Deutsch secondary locks, sealing bands, terminals and pins. The electrical pick, HD-41475-100, is also included. The kit includes a convenient compartmented storage box. The kit, HD-41475, retails for \$65.00.
