TECHNICAL

TIPS

August, 1998
TT#48

TECH TIPS #48

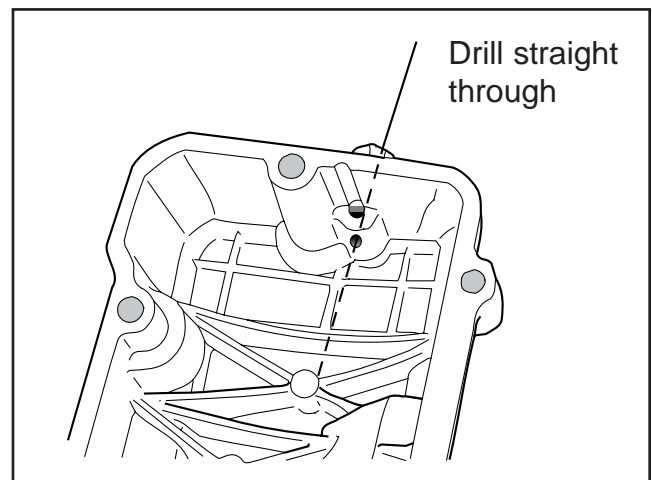
'98 Big Twin Transmission Cover

If you encounter a 1998 Big Twin transmission expelling lube out of the vent hose, there is now a modification that can be performed to reduce this occurrence. You need to remove the top cover from the transmission. Remove the vent line and fitting. Using a drill bit small enough to fit into threaded vent opening, drill a hole through to the inside of cover. Take care not to damage the threads in

vent opening. This modification would be used on rigid mounts after 11-15-97 and on rubber mounts after 6-1-97. If you have any concerns surrounding this, you should contact the Powertrain Service Group in Technical Service.

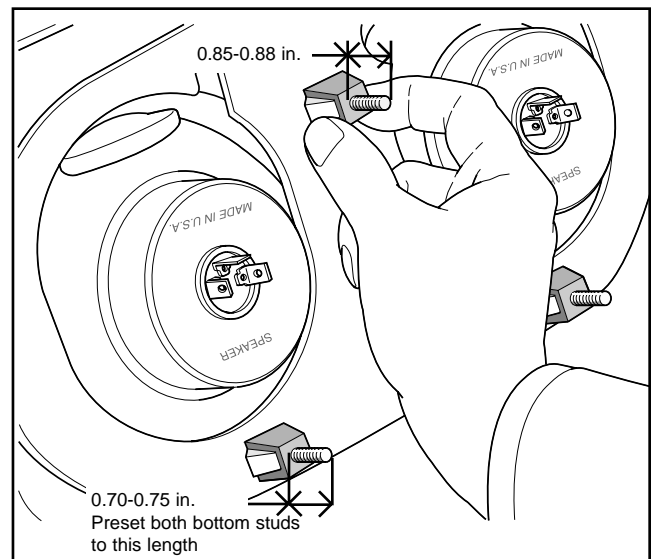
FLTR Headlamp Assembly

If you experience a loose headlamp assembly on a Road Glide, replace all three “green” mounting clips with black clips P.N. 67981-98A only. Attached is a crossview of this assembly with headlamp aim dimensions which should be set prior to installation of the outer fairing.

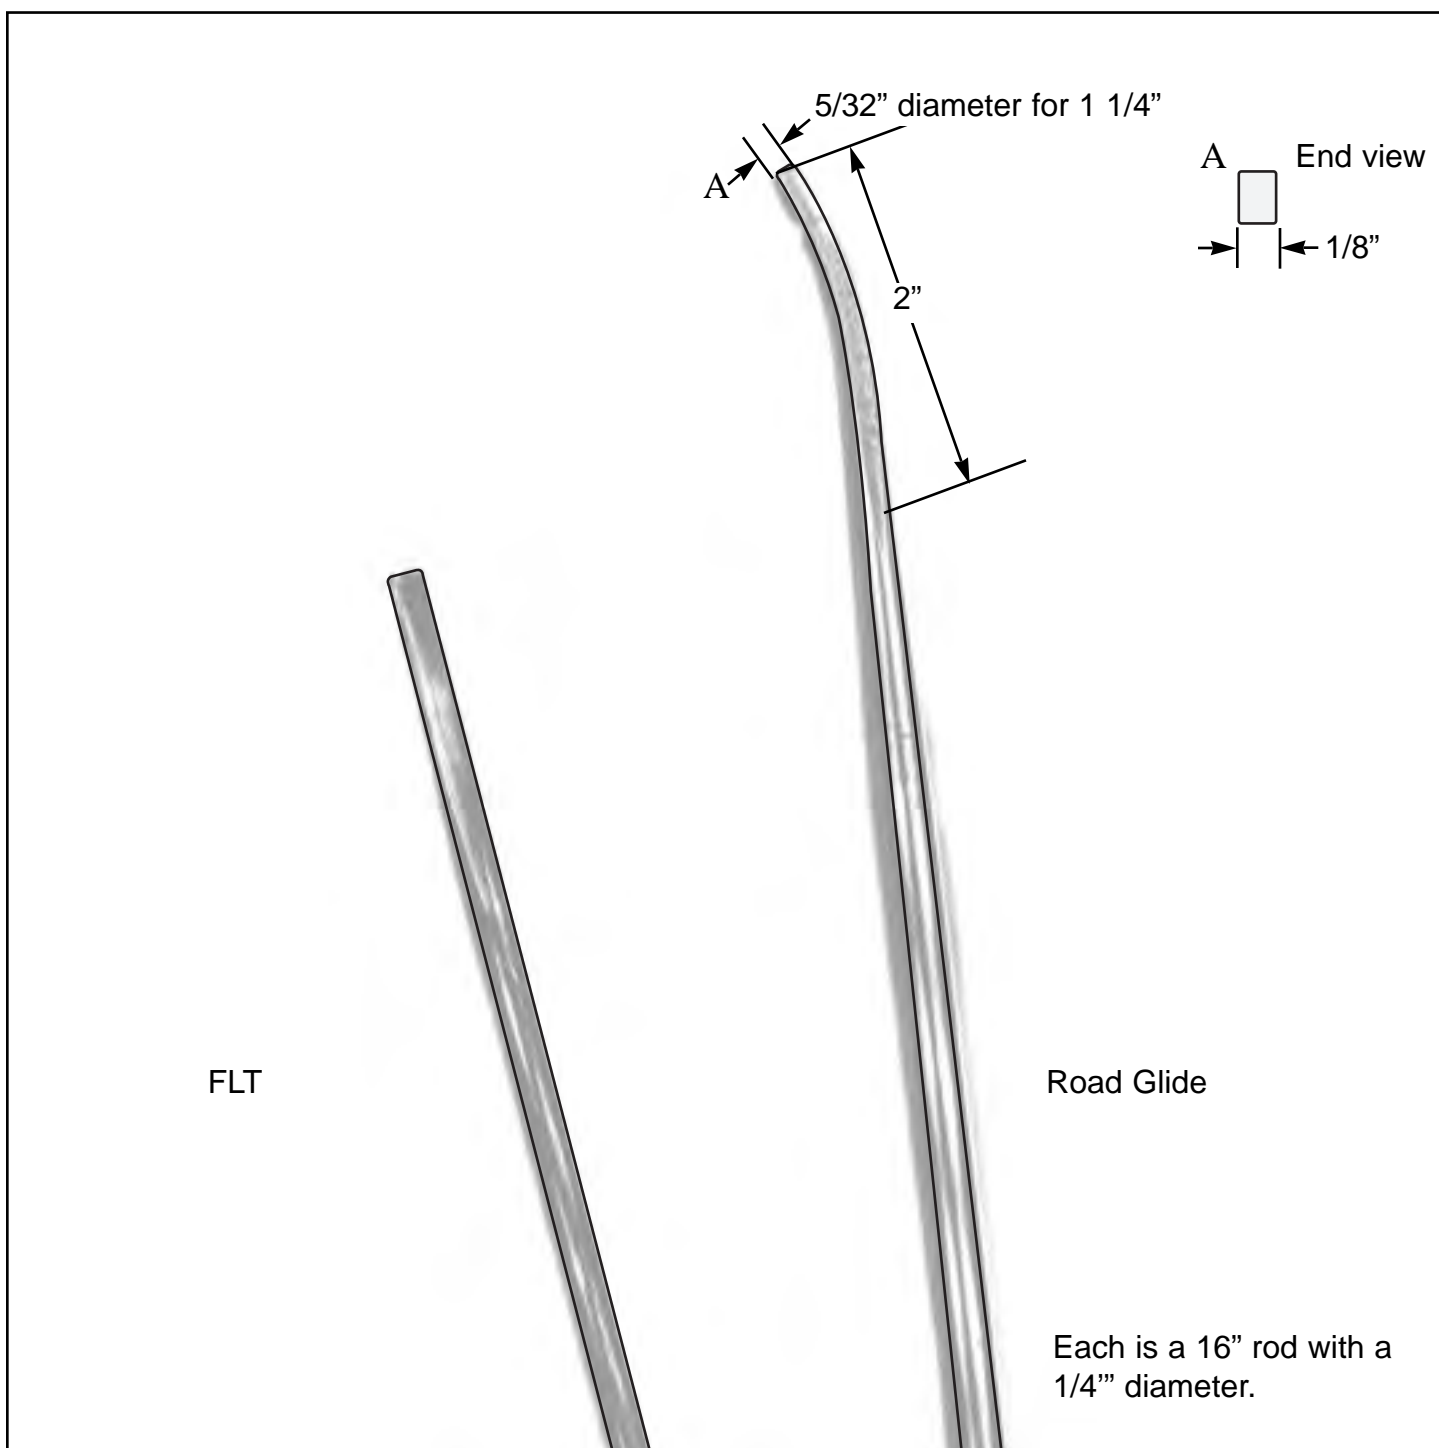
Attached is a picture showing a couple of helpful tools that technicians can make. They are used to adjust steering necks on FL models. The tools help to turn the star nut on steering stems. One is used on FLHT models and a slightly different version on Roadglides.
