TECH TIP # 56

December 2002 Issue

Tech Tips #56

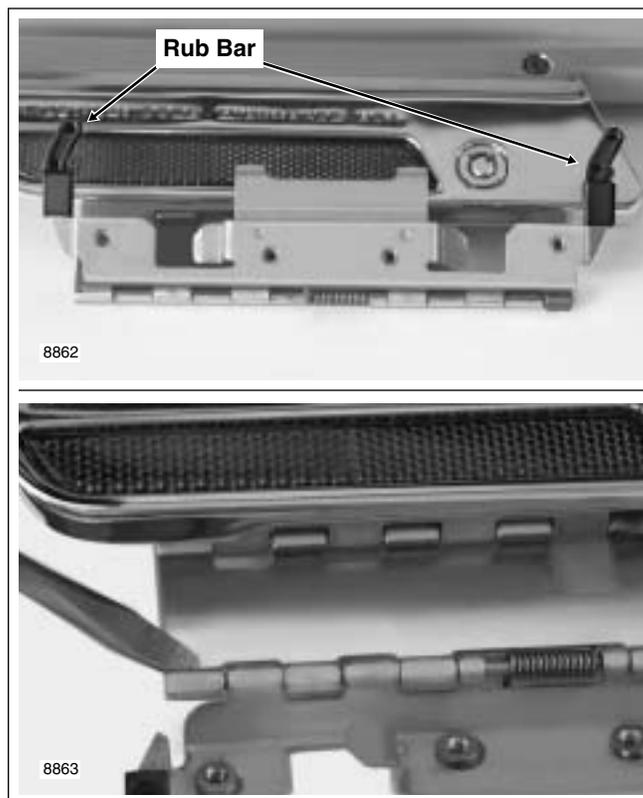
Figure 1. Lid Right Side Up With Latch on Near Side

7. Position lid right side up with latch closest to you.
8. Raise latch slightly and rotate hinge on inboard side so that it is topside with the two plastic rub bars pointed upward. See upper frame of Figure 1.
9. Rotate rub bar section of hinge to expose hinge pin and spring. Using a flat tip screwdriver, carefully bend crimped end link outward. See lower frame of Figure 1.

-
2. Slide pin back through links. Using tapered end of needle nose pliers, push end of pin into crimped link.
 3. Reposition lid so that it is right side up with latch closest to you. As before, raise latch slightly and rotate hinge on inboard side so that it is topside with plastic rub bars pointing upward. Now rotate rub bar section of hinge to expose hinge pin and spring. See Figure 1.

4. Holding lid down with elbow, if necessary, use a pliers to bend crimped link back into its original position, so that pin is captured and will not back out of hinge.

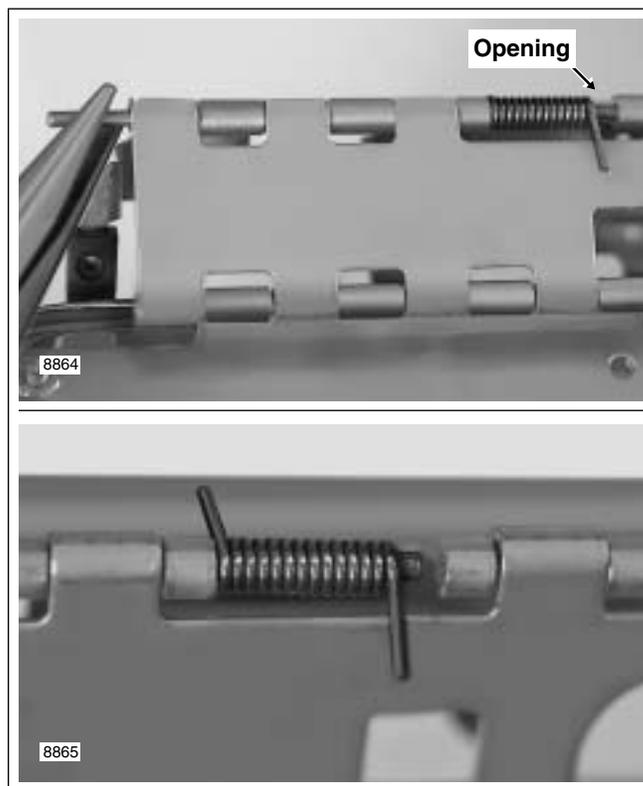
Figure 2. Lid Up Side Down With Latch on Far Side

10. Reposition lid so that it is upside down with the latch farthest from you. Rotate hinge so that plastic rub bars are positioned beneath latch and spring is topside.
11. Using a needle nose pliers, grasp pin through opening just outboard of the spring and push toward the crimped link side. Work pin in this manner until end can be seen exiting crimped link. See upper frame of Figure 2. If necessary, pry crimped link outward a little more to achieve the desired result.
12. Grasping end with needle nose pliers, slowly pull pin from links until spring can be slid off opposite end. Only pull pin as far as necessary to remove spring. See lower frame of Figure 2.

1. Slide **new** spring onto end of pin. Orient spring as shown in lower frame of Figure 2.
