Primary Housing To Crankcase/Transmission Interface

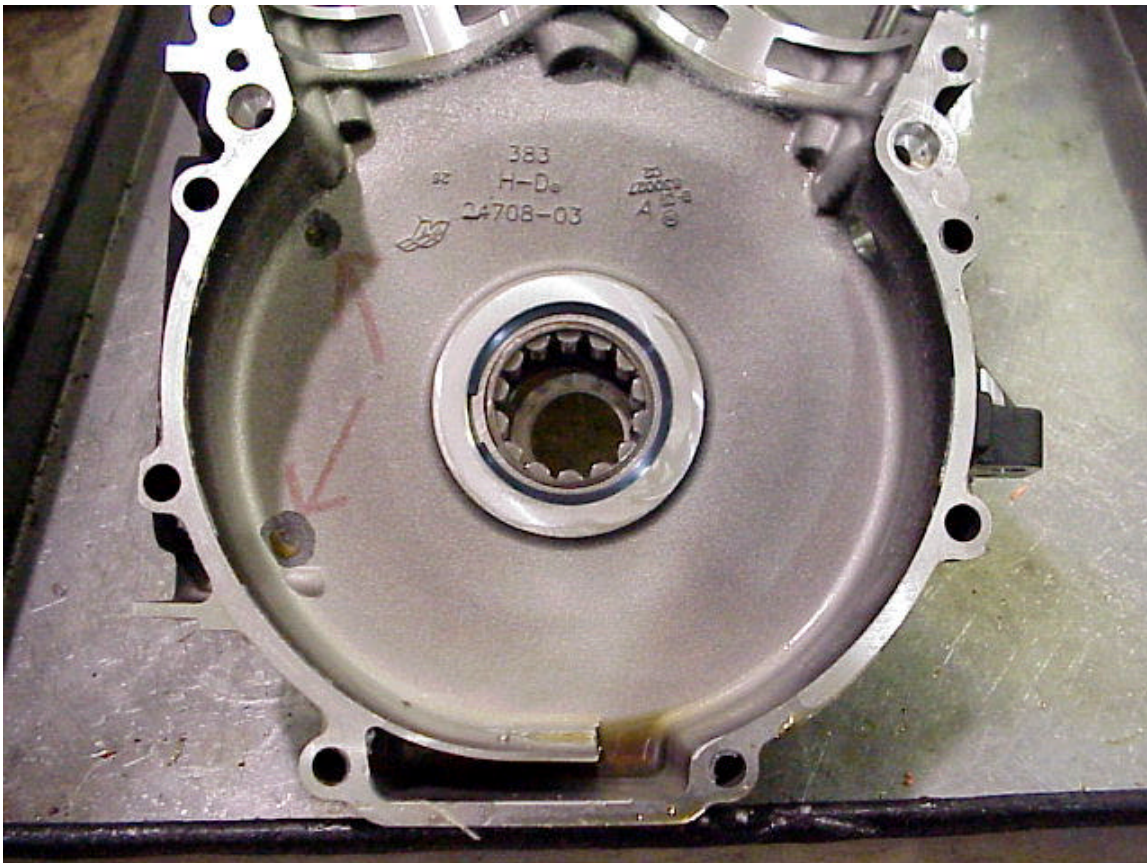
Sealant in blind holes can create real problems. Always verify cleanliness of blind holes before assembly. Observe all blind hole precautions outlined in the service manuals (Shop Practices, section 1.2). Excess debris, oil, sealant, water, Loctite, etc. can be trapped in the hole beneath the fastener and damage may occur when the fastener is tightened.

The photograph below shows the result of **improper** sealant application.

When servicing earlier vehicles, or if sealant is necessary to eliminate oil wicking past the internal primary mounting bolts, use only a light film of sealant around the bolt holes at the mating surfaces. Do not use sealer on the fasteners or case threads.
